## Management Unit 11

Ulster County - Town of Shandaken  
Bank Erosion Monitoring Site #18 to Cross Section 147

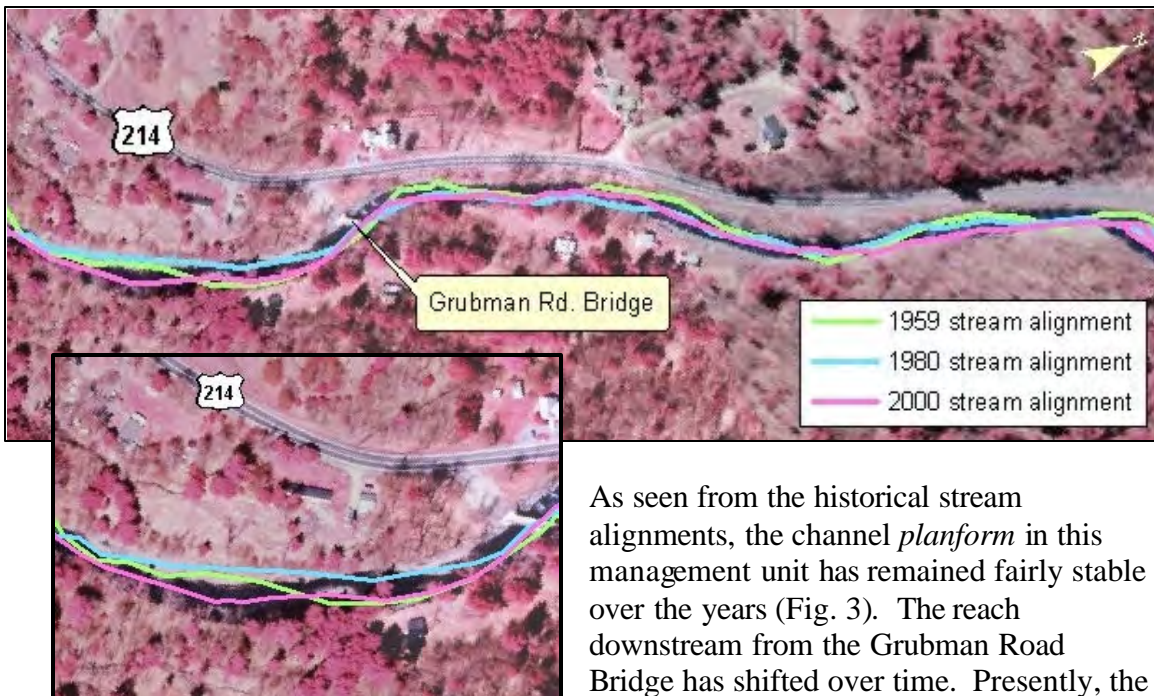
Figure 3 Historical stream channel alignments of Management Unit 11

As seen from the historical stream alignments, the channel *planform* in this management unit has remained fairly stable over the years (Fig. 3). The reach downstream from the Grubman Road Bridge has shifted over time. Presently, the channel has migrated against the left stream bank, causing erosion in this reach.

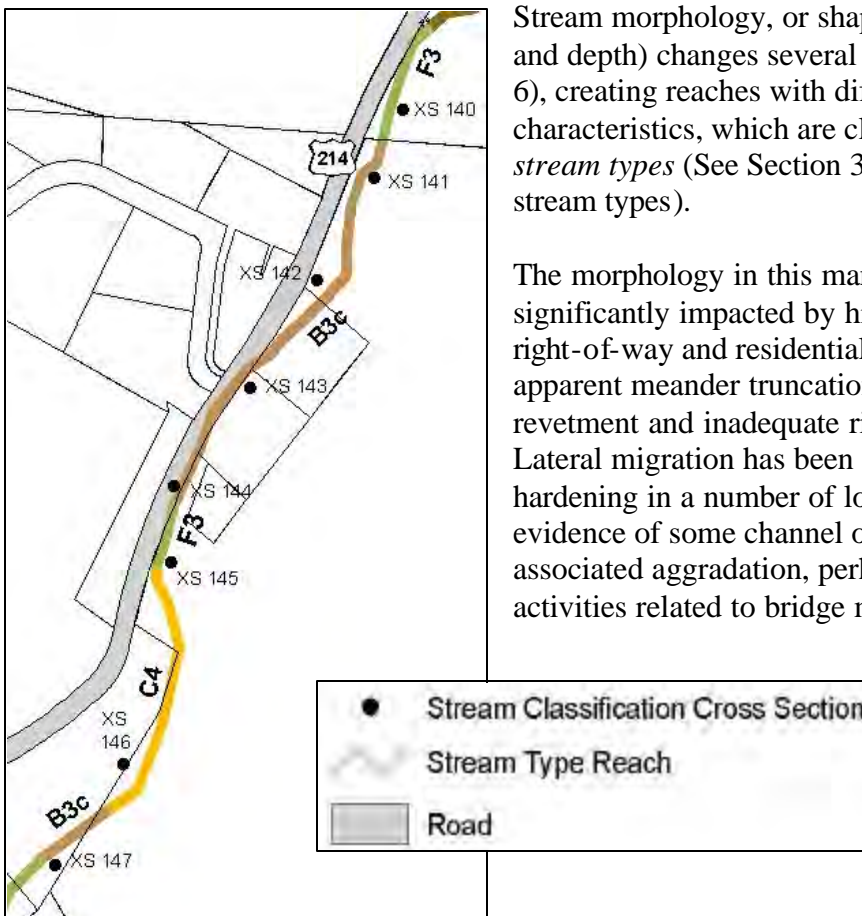
**Figure 6 Cross-sections and Rosgen stream types for Management Unit 11**

Stream morphology, or shape (i.e., slope, width and depth) changes several times in this unit (Fig. 6), creating reaches with differing morphologic characteristics, which are classified as different *stream types* (See Section 3.1 for description of stream types).

The morphology in this management unit is significantly impacted by highway, utility line right-of-way and residential encroachment, with apparent meander truncation, extensive bank revetment and inadequate riparian vegetation. Lateral migration has been controlled by the bank hardening in a number of locations, and there is evidence of some channel overwidening and associated aggradation, perhaps in response to activities related to bridge maintenance.

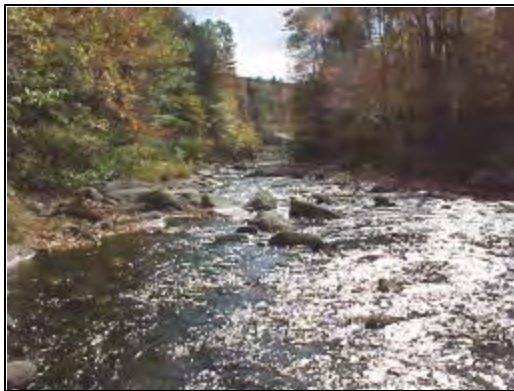
**Figure 9 Cross-section 141  
Stream Type B3c**

As the Stony Clove Creek crosses into Ulster County, stream type transitions into B3c for the next 1,108 ft. of stream (Fig. 9). This reach is moderately entrenched, gaining some access to its floodplain, and channel slope remains constant at 1.4%.

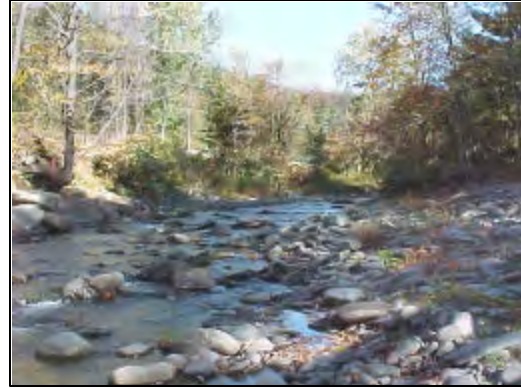
**Figure 11 Cross-section 145  
Stream Type F3, looking upstream**

Proceeding downstream, the channel begins to narrow, as the stream transitions into F3 stream type (Fig. 11). This 165 ft. reach is entrenched, with a channel slope of 1.5%, and a cobble-dominated bed.

At the top of this reach, bank erosion monitoring site #19 begins on the left stream bank and extends approximately 79 ft. downstream (Inset F). This 5 ft. high stream bank has experienced erosion during high flow events, leaving only exposed roots and soil on the stream bank.

The BEHI score of site #19 is ranked “Moderate”, the third lowest prioritization category in terms of its vulnerability to erosion. This bank erosion site is considered a low priority for restoration because of the absence of a significant threat to water quality or infrastructure and its small size (386 ft<sup>2</sup>).

Recommendations for this site include grading the stream bank to a slope suitable for revegetation with native trees and shrubs. Willow *fascines* could be installed at the toe of the stream bank to prevent undercutting of the new slope. In-depth survey and design would be required to plan a stream restoration project at this site.

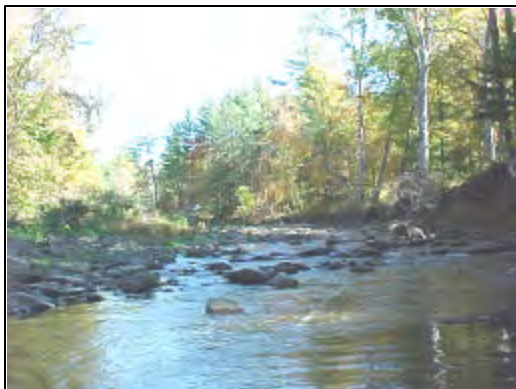
**Figure 12 Cross-section 146  
Stream Type C4, looking upstream**

As the channel reconnects with its floodplain, the stream type changes to C4 for the next 691 ft. (Fig. 12) The slope of the reach decreases to 1.1%, and the dominant bed material changes to gravel.

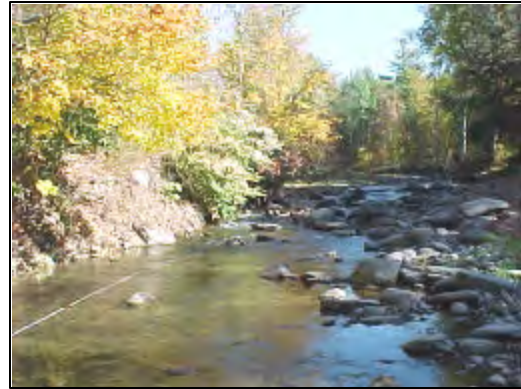
As the entrenchment moderates and bed material coarsens to cobble, stream type changes into B3c for the final 189 ft. of this management unit (Fig. 14). Channel slope of this reach increases to 1.6%. The left bank erosion ends midway through this reach.

**Figure 14 Cross-section 147  
Stream Type B3c, looking upstream**

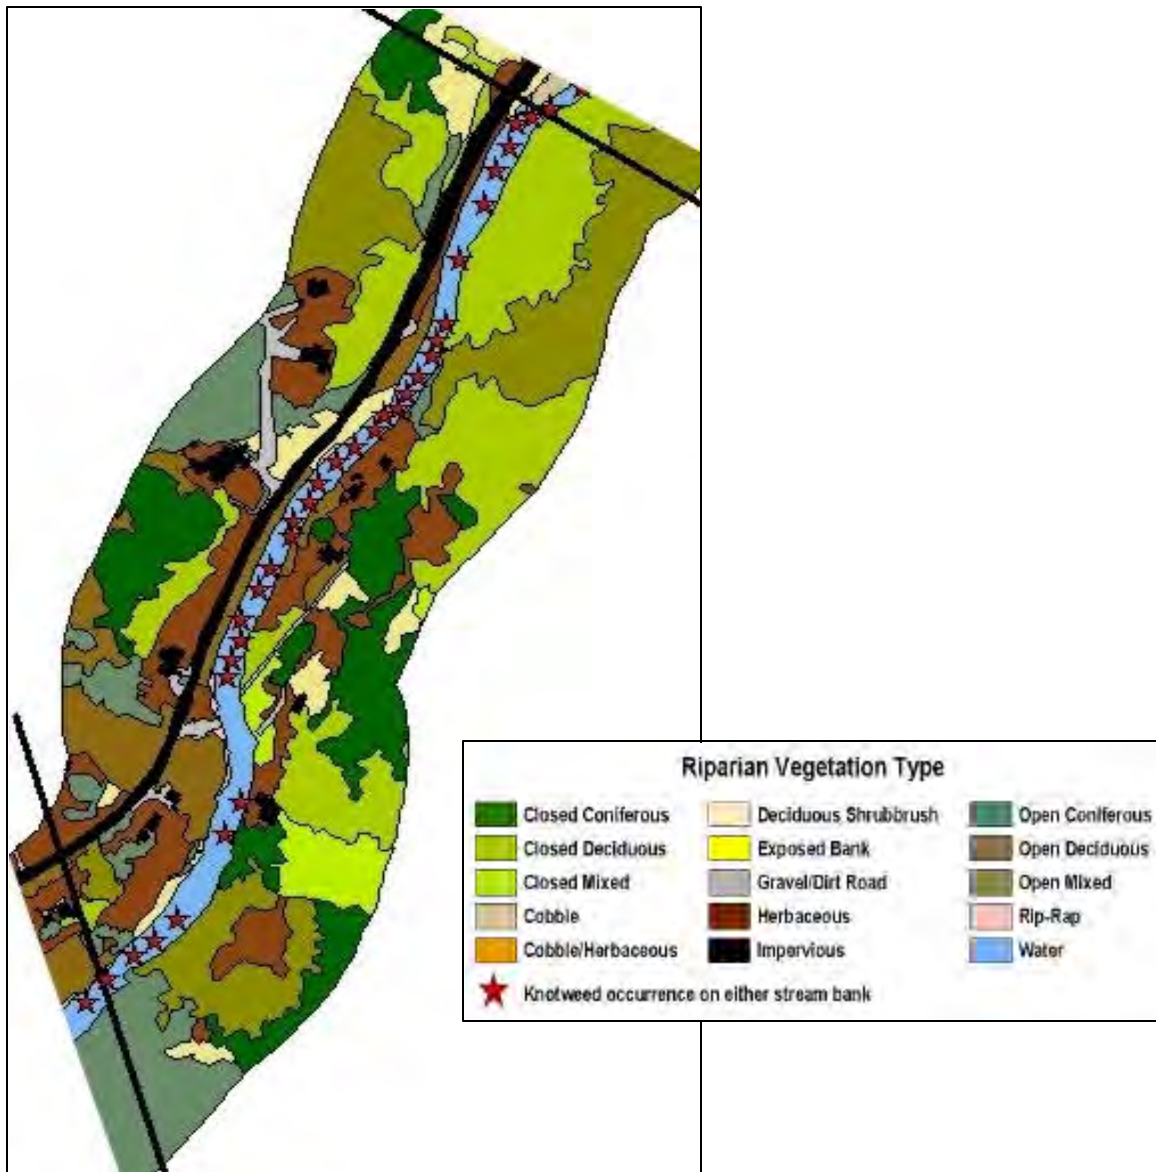
**Figure 15 Riparian vegetation map of Management Unit 11**

The predominant vegetation type within the 300 ft. riparian buffer is forested (74%) followed by herbaceous (15%). Areas of herbaceous (non-woody) cover present opportunities to improve the riparian buffer planting with more flood-resistant species. *Impervious* area (5%) within this unit's buffer is primarily the NYS Route 214 roadway and private residences. The presence of Japanese knotweed is pervasive in this management unit.

Just over half of the length of this management unit lies within 50 ft. of NYS Route 214. The riparian vegetation between the stream and the highway is in generally poor health, in part due to highway corridor and utility line right-of-way management. As a result, its contribution to stream bank stability and ecosystem health is limited.

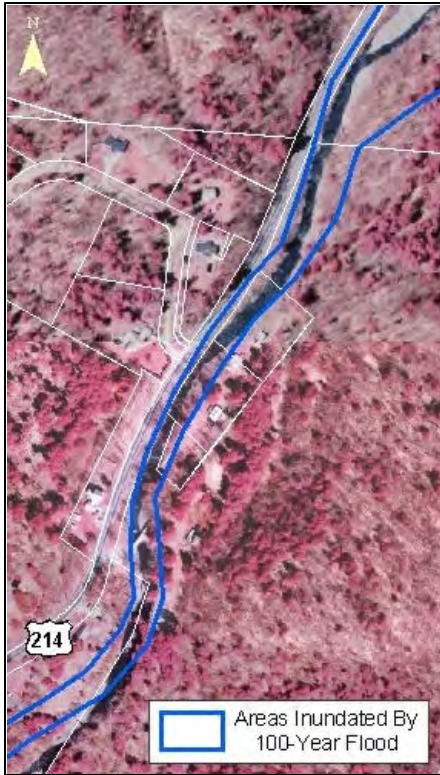
**Figure 21 100-year floodplain boundary in Management Unit 11**

According to the NFIP maps, there are no houses located within the 100-year floodplain boundary in this management unit (Fig. 21). The current NFIP maps are available for review at the Greene and Ulster County Soil & Water Conservation District offices.
