Management Unit 12

Ulster County - Town of Shandaken
Cross Section 147 to between Cross Section 149 & 150

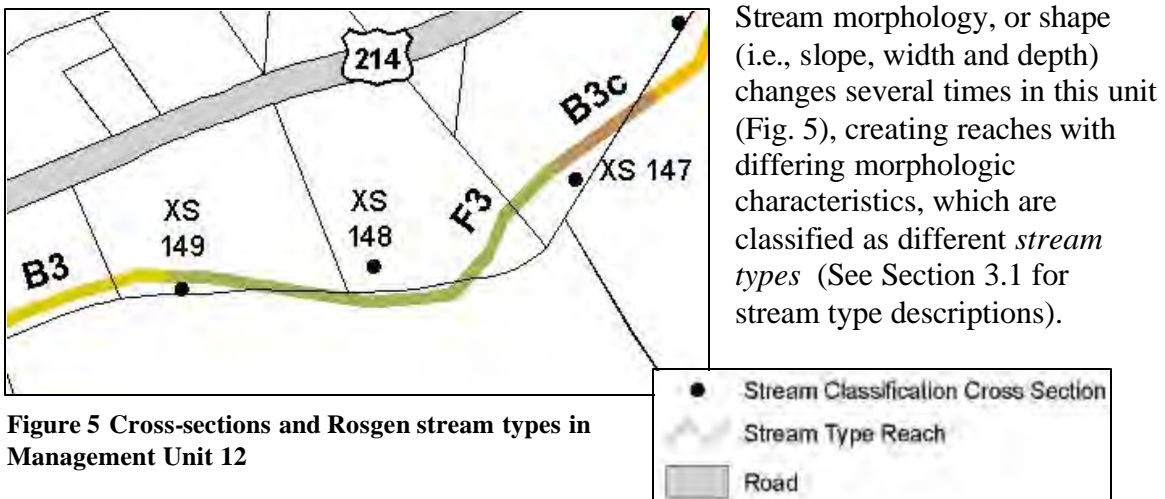
Figure 5 Cross-sections and Rosgen stream types in Management Unit 12

Entrenched and overwide conditions dominate most of this unit, with large cobble dominating bed material throughout. Unconsolidated glacial deposits within the unit appear to contribute significant amounts of larger cobble and boulder bedload. Channel slope is fairly flat at 1.5%.

Management unit #12 begins at cross section 147, with a short 25 ft. reach of B3c stream type (Inset D). This stream reach is moderately *entrenched*, or confined within the stream banks during high flow events. Stream channel slope is fairly flat at 1.6% and the dominant bed material is cobble.

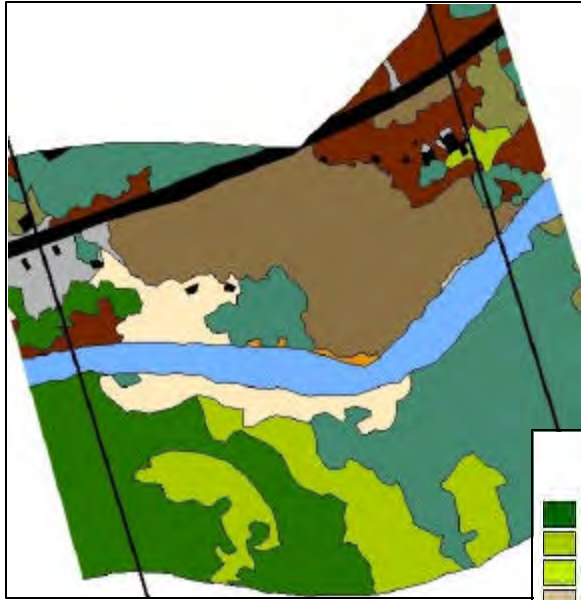
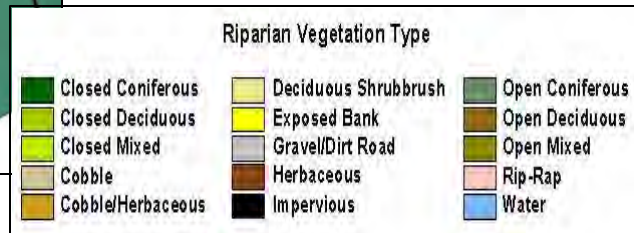
Figure 8 Riparian vegetation map of Management Unit 12

The predominant vegetation type within the 300 ft. riparian buffer is forested (79%) followed by deciduous shrubbrush (8%) and herbaceous (7%). Areas of herbaceous (non-woody) cover present opportunities to improve the riparian buffer with plantings of more flood-resistant species. *Impervious* area (4%) within this unit's buffer is primarily the NYS Route 214 roadway and private residences.

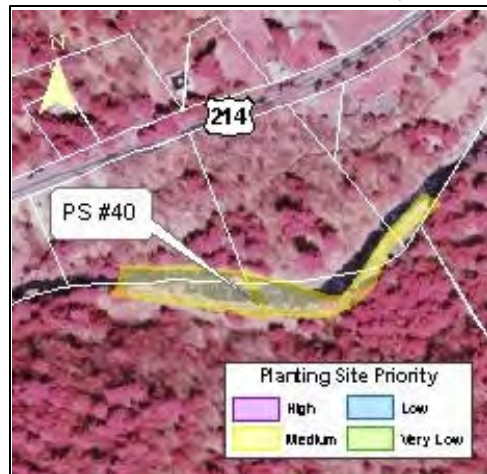
Figure 9 Planting site location map for Management Unit 12

Planting site #40 is located in the overwide reach at the middle of the management unit (Fig. 10 & Inset C). The left stream bank in the reach has experienced minor erosion which has stripped away most of its vegetation. The angle of this bank is quite low and can support vegetation establishment in its current condition. At the top of the bank is a large mowed grass area. Japanese Knotweed is present on both stream banks.

In-channel plantings of willow fascines and native sedges along the toe of the stream bank are recommended. These planting will encourage the stream to narrow into a more stable morphology. Native shrubs should also be installed on the face of the bank. There is a small amount of willows along the right bank, the tops of which could be harvested as cuttings, without damaging the root system, and used to revegetate the left stream bank. This practice actually increases the vigor of the parent willow, as the root system is strengthened and the crowns of the harvested willows will sprout new branches. The upland grass area should be converted to forest to improve the stream buffer and overhead cover. These plantings will help to stabilize this stream bank, while adding aquatic habitat value by improving shading, resulting in cooler water temperatures. Aggressive Japanese knotweed management is recommended throughout the unit, but particularly in those locations where treatments disturb and expose soil in the banks.

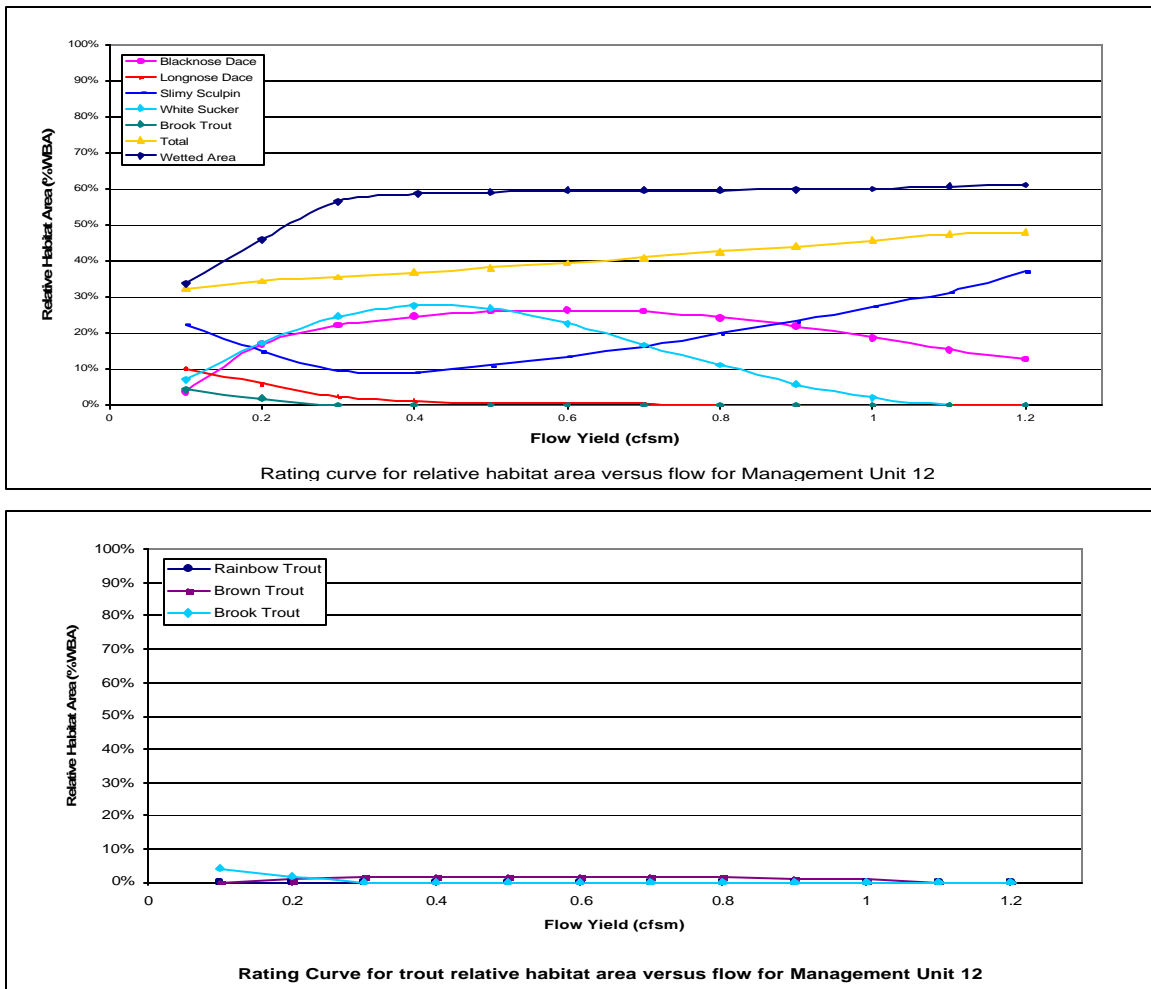
Figure 12 MesoHABSIM habitat rating curves for Management Unit 12

Management unit #12 has the highest diversity of *hydro-morphologic units* (HMUs) at 0.3 cfs. As flow changes, the size and location of the HMUs change, but dominant types (riffle, rapid, run) stay the same. Shallow margins are abundant throughout the management unit, and ample boulder cover is available. The *wetted area* almost doubles between flows of 0.1 cfs and 0.3 cfs and then stays constant, though with fewer and faster flowing HMUs. Suitable habitat within this management unit is relatively high. Slimy sculpin habitat lowers at around 0.3 cfs, and then increases with flow. Blacknose dace and white sucker habitat peak before 1.0 cfs and then decline. Longnose dace have some low quality habitat at low flows and then it disappears by 1.0 cfs. Habitat for trout species however, is either unavailable or very poor. (See Section 6.6 general recommendations for aquatic habitat improvement)
