Management Unit 13

Ulster County - Town of Shandaken
Between Cross Section 149 & 150 to Cross Section 153

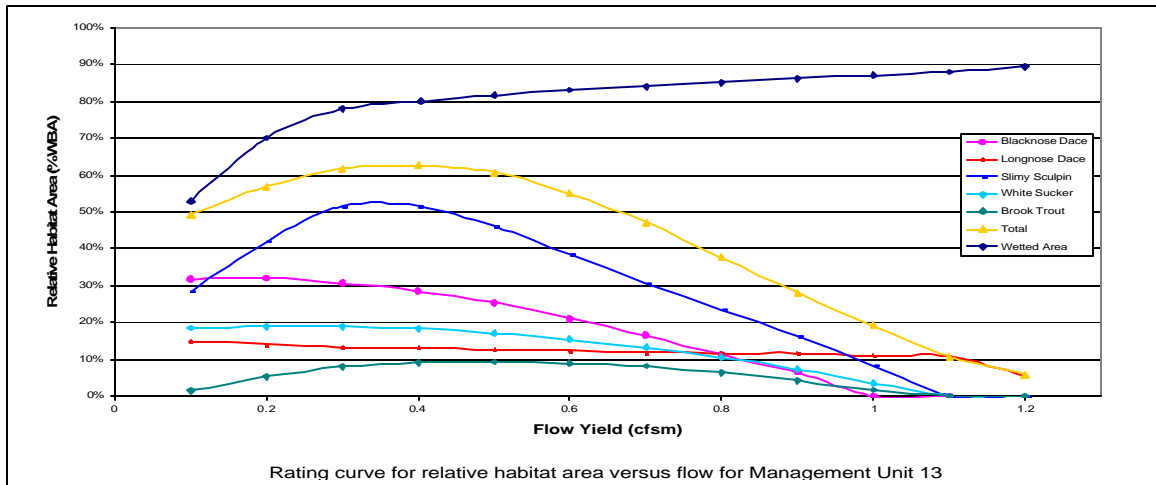
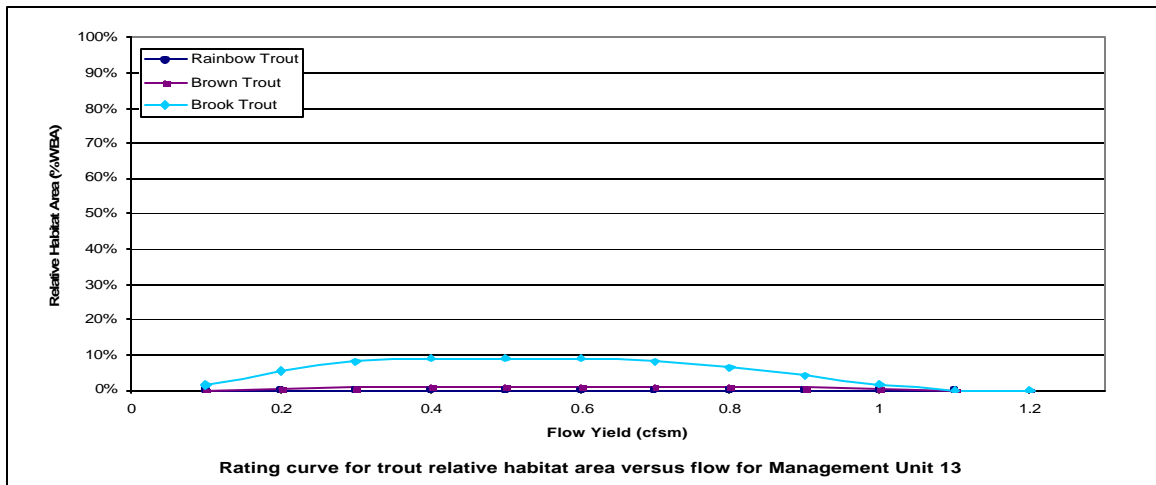
Figure 17 MesoHABSIM habitat rating curves for Management Unit 13

Management unit #13 is located very close to the road and has a habitat pattern somewhat similar to both management units #11 and #12, although more glides appear. At lower flows, a little more than half of the bankfull *wetted area* is covered with water, with extensive shallow margin areas and some rip-rap. The *hydro-morphologic units* (HMUs) decrease in number and enlarge in area when approaching 1.0 cfs. Wetted area approaches the bankfull wetted area quickly. The proportion of suitable habitat reaches

its peak around 0.35 cfs/m and then declines substantially with increasing flows. The curve for slimy sculpin reflects the overall habitat-rating curve with a peak around 0.35 cfs/m. Blacknose dace and white sucker start at stable habitat levels, but then lose all their habitat by 1.0 cfs/m. Longnose dace habitat is also at low levels, but declines more slowly. Brook trout habitat increases to almost 10% around 0.5 cfs/m, but then also declines to zero. The other two trout species have a negligible amount of usable habitat available. (See Section 6.6 general recommendations for aquatic habitat improvement)
