Management Unit 14
 Ulster County - Town of Shandaken
 Cross Section 153 to Weiss Road Bridge

Management Unit Description

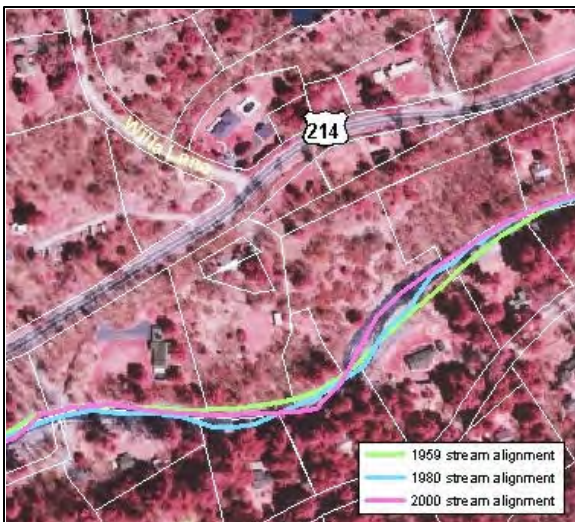
Figure 3 Historic channel alignments in Management Unit 14

As seen from the historical stream alignments, the *planform* of the stream channel has remained fairly stable over the years (Fig. 3).

At the top of the management unit, on the right, some channel shifting is evident. The channel was realigned to the right following the 1996 flood, to increase its distance from the house. The channel created by the flood flows was filled with the excavated material.

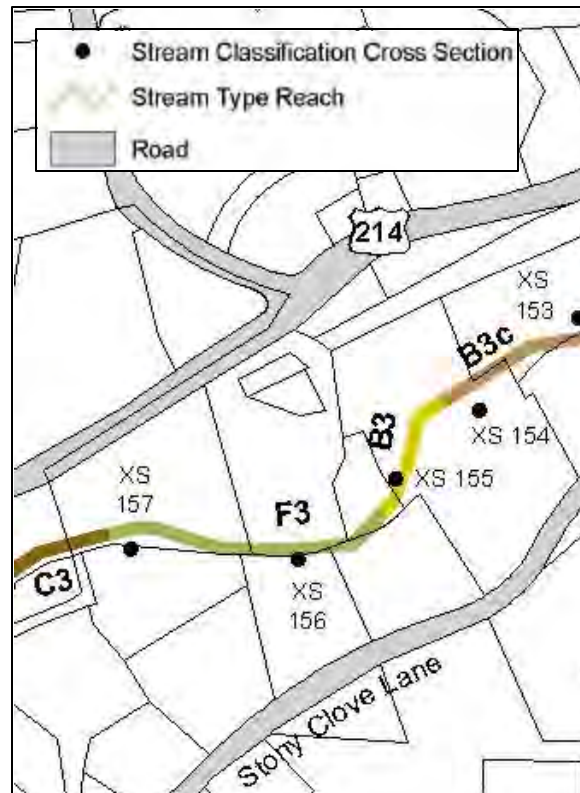
Figure 5 Cross-sections and Rosgen stream types in Management Unit 14

The stream morphology, or shape (i.e., slope, width and depth) changes frequently in this unit (Fig. 5), creating small reaches with differing morphologic characteristics, which are classified as different *stream types* (See Section 3.1 for stream type descriptions).

Morphology in this unit has been significantly modified, with extensive channel grading at the top of the reach, and berm-induced entrenchment at the bottom. Despite these disturbances, the unit appears to be recovering. As many of the disturbances are relatively recent, this unit should be monitored for unfavorable response trends, including vertical and lateral adjustments.

Management unit #14 begins with a 362 ft. reach of B3c stream type (Inset D). This stream reach is moderately *entrenched*, or confined within the stream banks during high flow events. Stream channel is very flat with a slope of 0.5% and dominant bed material is small cobble.

This reach is overwide and shallow. Deposition is common in overwide channels because they lose their ability to transport the stream's *bedload*, resulting in *aggradation*, or a rise in stream bed elevation. Overwide channels typically offer poor fish habitat due to warmer water temperatures and filling of deep pools.

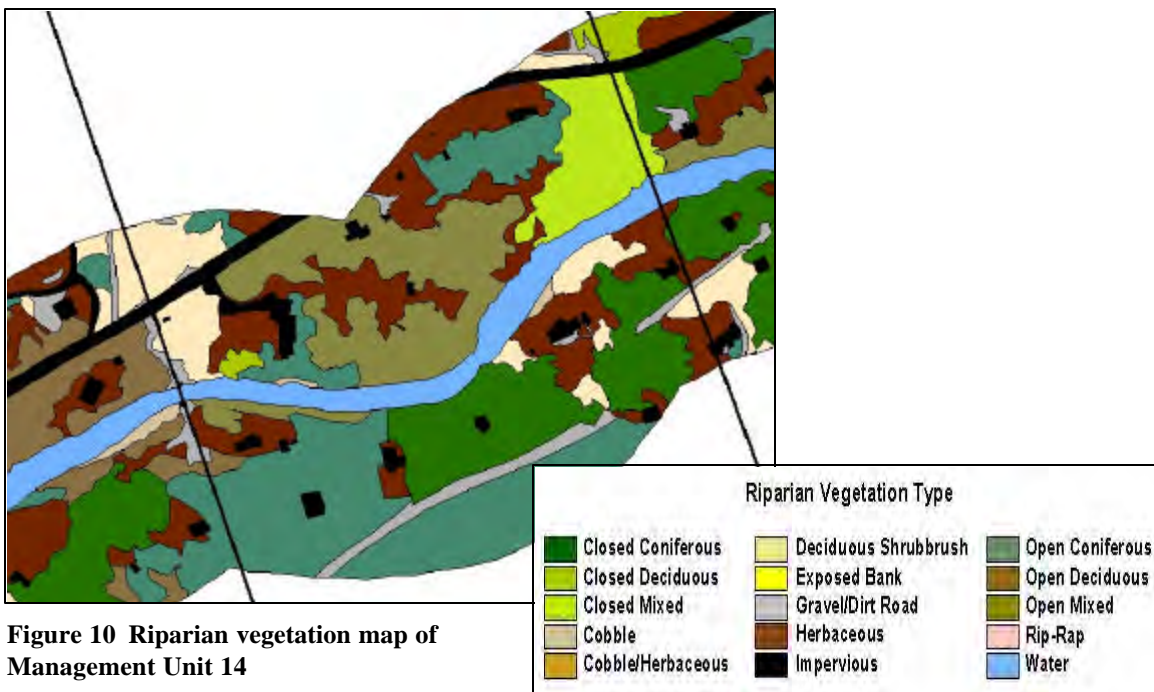
Figure 10 Riparian vegetation map of Management Unit 14

The predominant vegetation type within the 300 ft. riparian buffer is forested (65%) followed by herbaceous (19%) and deciduous shrubbrush (8%). Areas of herbaceous (non-woody) cover present opportunities to improve the riparian buffer with plantings of more flood-resistant species. *Impervious* area (5%) within this unit's buffer is primarily the NYS Route 214 roadway and private residences.

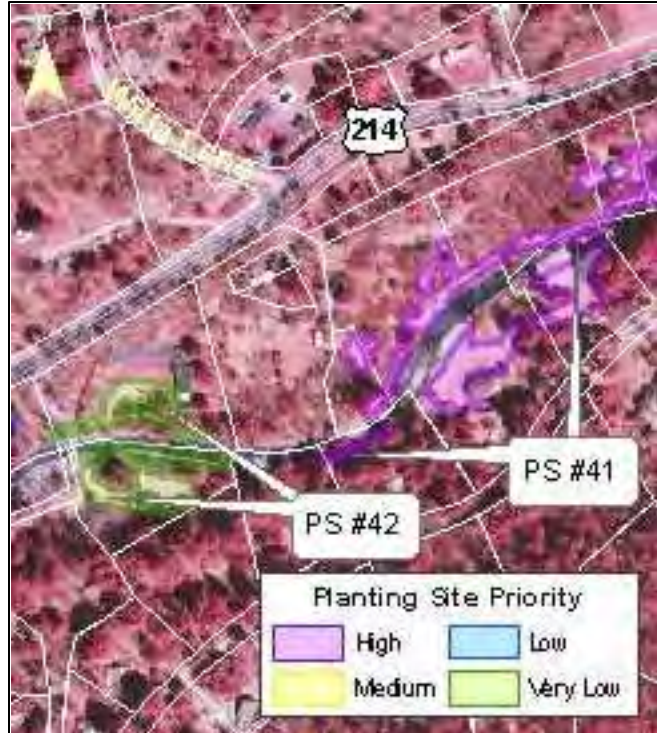
Figure 11 Planting site location map for Management Unit 14

In June 2003, suitable riparian improvement planting sites were identified through a watershed-wide field evaluation of current riparian buffer conditions and existing stream channel morphology (Fig. 11). These locations indicate where plantings of trees and shrubs on and near stream banks can help reduce the threat of serious bank erosion, and can help improve aquatic habitat as well. In some cases, eligible locations include stream banks where rock rip-rap has already been placed, but where additional plantings could significantly improve stream channel stability in the long-term, as well as biological integrity of the stream and floodplain. Areas with serious erosion problems where the stream channel requires extensive reconstruction to restore long-term stability have been eliminated from this effort. In most cases, these sites can not be effectively treated with riparian enhancement alone, and full restoration efforts would include re-vegetation components. Two appropriate planting sites were documented within this management unit.

Planting site #41, which includes six properties on both the left and right stream banks, is located at the top of this management unit (Fig. 12).

Recommendations for this site include *joint planting* the existing rip-rap on both banks, by inserting plantings into the soil between the rip-rap rocks. Joint planting will strengthen and increase the longevity of the rip-rap. These plantings will also improve the aquatic habitat by providing shade, which maintains cooler water temperatures. Upland plantings of native trees and shrubs in the grass areas will also improve the stability of these banks and increase the buffer functionality.

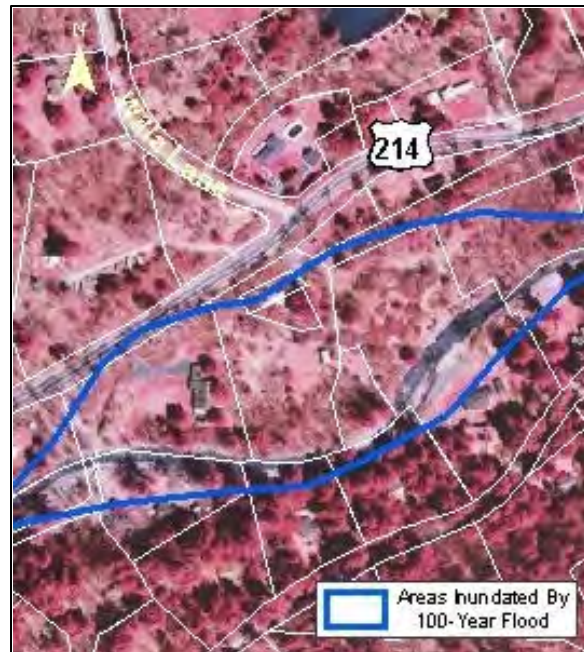
Figure 14 100-year floodplain boundary in Management Unit 14

According to the NFIP maps, there are four houses located within the 100-year floodplain boundary in this management unit (Fig. 14). The current NFIP maps are available for review at the Greene and Ulster County Soil & Water Conservation District offices.
