Management Unit 14
 Ulster County - Town of Shandaken
 Cross Section 153 to Weiss Road Bridge

Management Unit Description

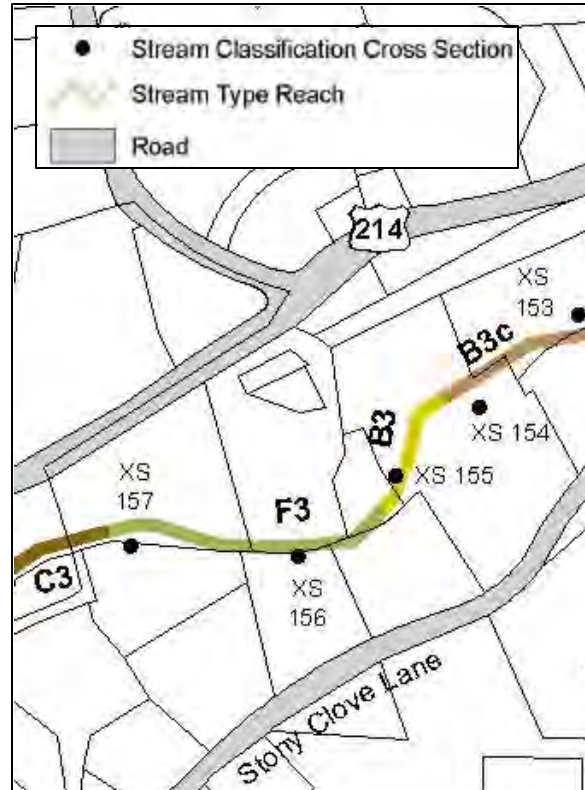
Figure 5 Cross-sections and Rosgen stream types in Management Unit 14

The stream morphology, or shape (i.e., slope, width and depth) changes frequently in this unit (Fig. 5), creating small reaches with differing morphologic characteristics, which are classified as different *stream types* (See Section 3.1 for stream type descriptions).

Morphology in this unit has been significantly modified, with extensive channel grading at the top of the reach, and berm-induced entrenchment at the bottom. Despite these disturbances, the unit appears to be recovering. As many of the disturbances are relatively recent, this unit should be monitored for unfavorable response trends, including vertical and lateral adjustments.

Management unit #14 begins with a 362 ft. reach of B3c stream type (Inset D). This stream reach is moderately *entrenched*, or confined within the stream banks during high flow events. Stream channel is very flat with a slope of 0.5% and dominant bed material is small cobble.

This reach is overwide and shallow. Deposition is common in overwide channels because they lose their ability to transport the stream's *bedload*, resulting in *aggradation*, or a rise in stream bed elevation. Overwide channels typically offer poor fish habitat due to warmer water temperatures and filling of deep pools.

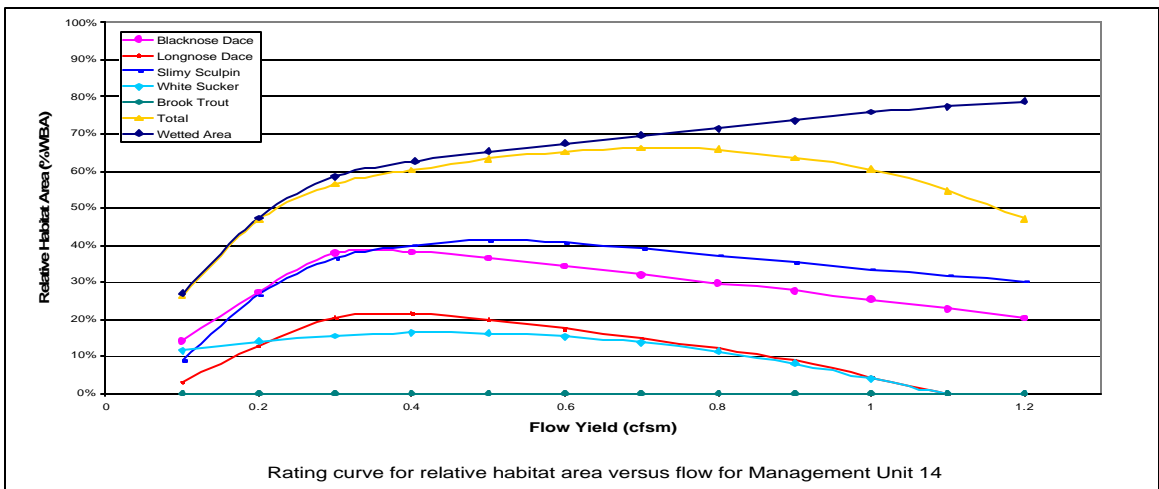
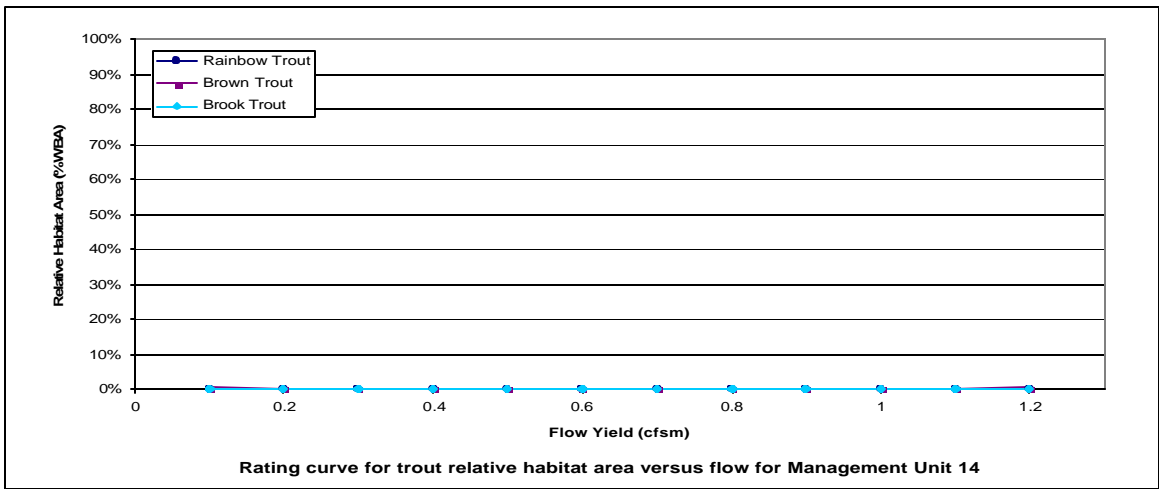
Figure 15 MesoHABSIM habitat rating curves for Management Unit 14

Management unit #14 has an abundance of shallow margins and should therefore offer good nursery habitat. It also offers some glides along with faster types of units at flows under 1.0 cfs. With a flow increase above 1.0 cfs, however, it turns into sizeable ruffle-run sequences only. The *wetted area* covers from one-third to two-thirds of bankfull wetted area, but the largest increase in wetted area occurs between flows of 0.1 cfs and 0.3 cfs. This causes a rapid increase in suitable habitat area for low flows, with a gradual decline afterward. Slimy sculpin and blacknose dace have similar levels of habitat with a peak between 0.3 cfs and 0.8 cfs and then a gradual decline. Longnose dace and white sucker have half as much habitat available than the other two species with a decline above 0.3 cfs. Brook trout have no habitat available and the other trout species have only low probability areas. Low flows create twice as many habitat overlaps as higher flows. (See Section 6.6 general recommendations for aquatic habitat improvement)
