Management Unit 16
 Ulster County - Town of Shandaken
 Warner Creek to Silver Hollow Bridge

Management Unit Description

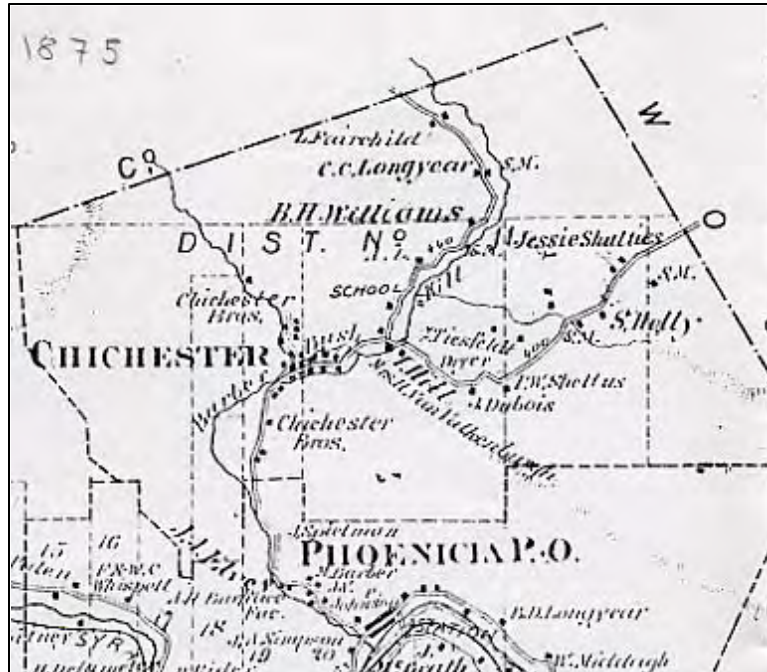
Figure 2 Excerpt from F.W. Beers 1875 Atlas of Ulster County

By 1875, when F.W. Beers published his Atlas of Ulster County, the road up Silver Hollow had led to settlement along Warner Creek as far as the Woodstock town line, with several sawmills in operation (Fig. 2). The watershed further upstream on this, the largest of the tributaries of Stony Clove Creek, had already been tapped for hemlock by Colonel Edwards during the mid-1800s via his bark road extension at Edgewood. Hardwood logging also reached into the top of Silver Hollow.

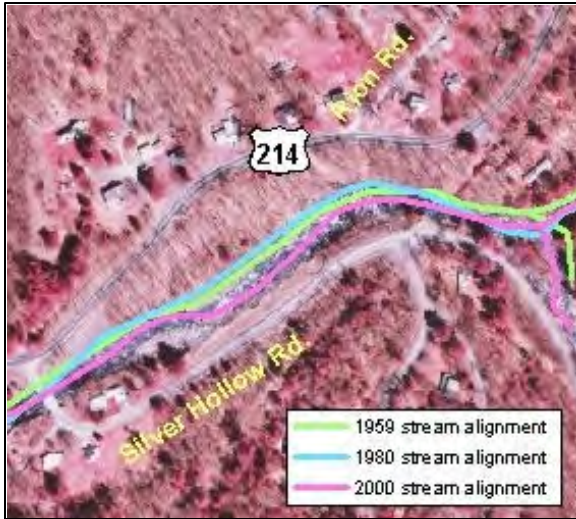
Figure 4 Historic stream alignments in Management Unit 16

As seen from the historical stream alignments, the *planform* of the channel has remained fairly stable over the years, owing primarily to confinement by the valley form (Fig. 4).

There has been some channel movement in the middle of the management unit, beginning at the old railroad abutments. Between 1980 and 2000, the stream channel was shifted to the left, toward Silver Hollow Road. Rip-rap revetment was placed on the right banks, which during the 1996 flood, caused severe erosion on the left stream bank. Ulster County Soil and Water Conservation

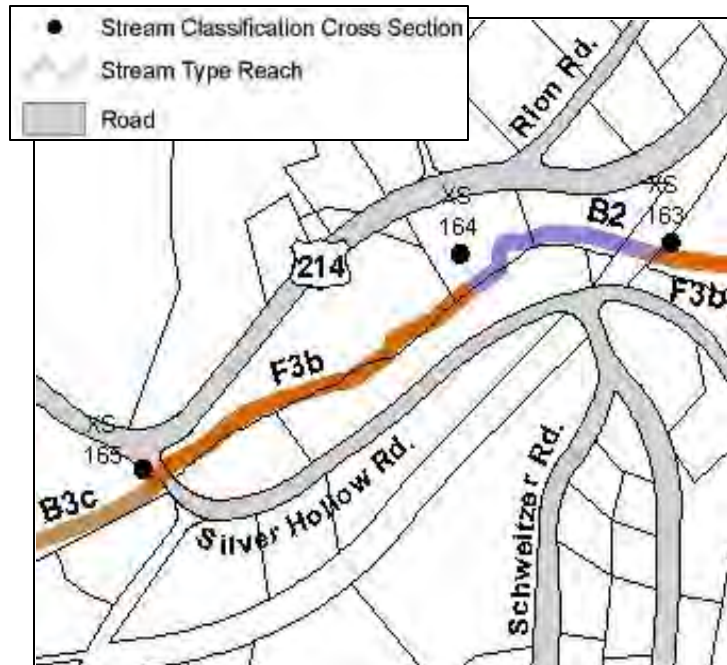
Figure 7 Cross-sections and Rosgen stream types in Management Unit 16

Stream morphology, or shape (i.e., slope, width and depth), alternates between “F” and “B” stream types through this unit (Fig. 7, See Section 3.1 for description of stream types).

Constrained by road embankments, railroad crossing and valley form, this unit has been extensively manipulated. Bed material size is very large through much of the reach, and slope is quite steep. This unit includes the confluence of Warner Creek, contributing a 50% increase in drainage area. Clay exposures provide evidence of incision in the middle

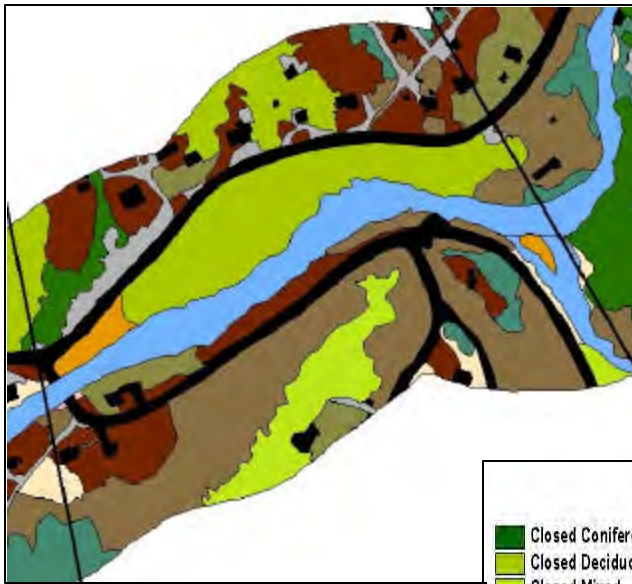
Figure 15 Riparian vegetation map for Management Unit 16

An analysis of vegetation was conducted using aerial photography from 2001 and field inventories (Fig. 15, Appendix A). Japanese knotweed occurrences were documented as part of the MesoHABSIM aquatic habitat inventory conducted during the summer of 2002 (Appendix B).

The predominant vegetation type within the 300 ft. riparian buffer is forested (61%) followed by herbaceous (16%). Areas of herbaceous (non-woody) cover present opportunities to improve the riparian buffer with plantings of more flood-resistant species. *Impervious* area (12%) within this unit's buffer is primarily the NYS Route 214 and Silver Hollow Road along with private residences.

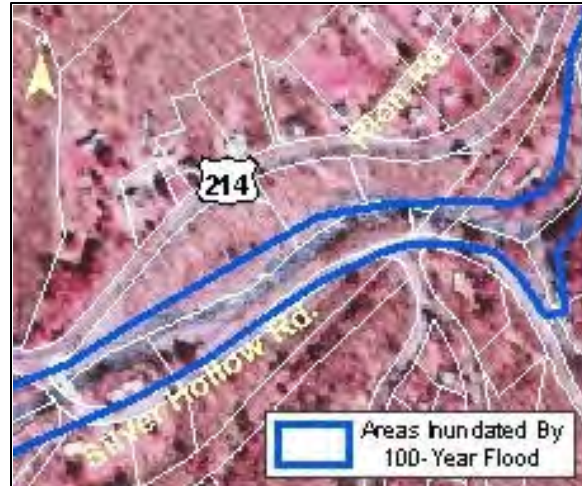
Figure 16 100-year floodplain boundary in Management Unit 16

According to the NFIP map, there are two houses within the 100-year floodplain boundary in this management unit (Fig. 16). The current NFIP maps are available for study at the Greene and Ulster County Soil & Water Conservation District offices.
