## Management Unit 19

Ulster County - Town of Shandaken  
Chichester Bridge to Between Cross Section 186 & 187

### Management Unit Description

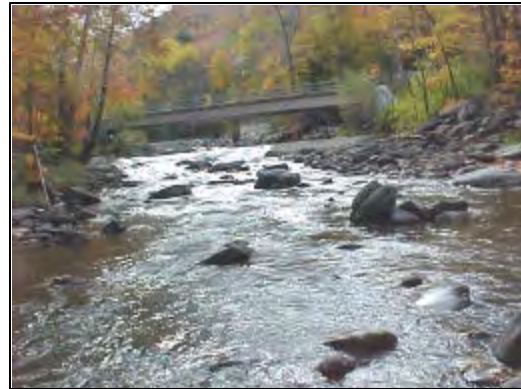
Figure 5 Stream Type B3 looking upstream

Management unit #19 begins as the Stony Clove emerges from under the Chichester Bridge, with a 191 ft. reach of B3 stream type (Fig.5). The stream channel is moderately *entrenched*, or confined within the stream banks during high flood events. The slope of the stream channel is 2.0%. The bed material is dominated by cobble, but large boulders and bedrock are abundant.

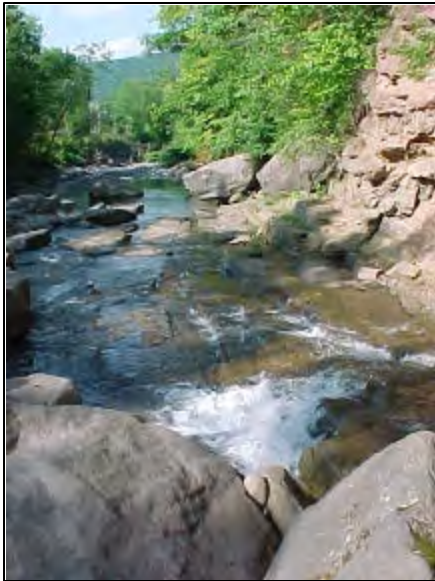
**Figure 7 Cross-section 178  
Stream Type C2**

As the dominant bed material increases to boulders, stream type transitions to C2 for a short 168 ft. reach (Fig. 7). This reach remains steep with a slope of 1.8% and consists of a large cascade. For approximately the first third of this reach, the bed and right stream bank are bedrock.

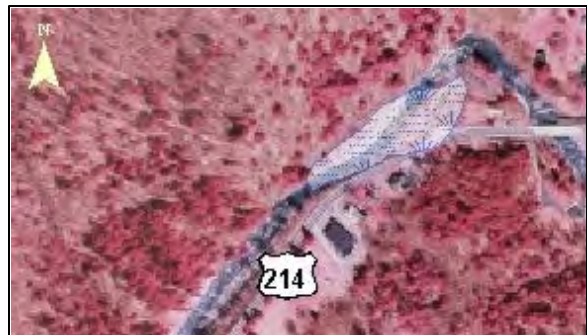
**Figure 8 Federally Designated Wetland**

There is a federally designated wetland along the stream in this management unit (Fig. 8). This wetland, which is 1.6 acres in size, is classified as palustrine scrub-shrub, broad-leaf deciduous, and temporarily flooded (PSS1A).

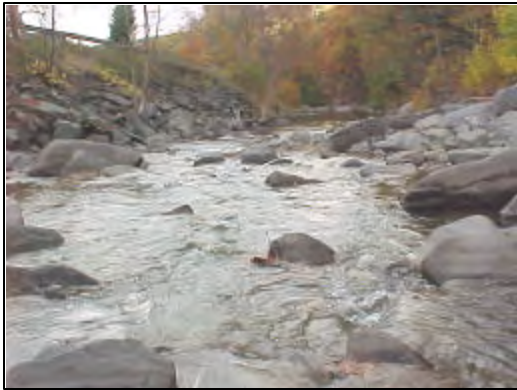
**Figure 9 Cross-section 179  
Stream Type B3c**

The channel becomes moderately entrenched by the NYS Route 214 embankment on the left, and the dominant bed material decreases to cobble, as stream type changes to B3c for the next 306 ft. reach (Fig. 9). In the middle of this reach, the overflow channel rejoins with the Stony Clove mainstem. The *thalweg*, or deepest part of the stream, flows against the steep left stream bank. The NYS DOT has installed 326 ft. of rip-rap (Inset F) along the lower half of this bank.

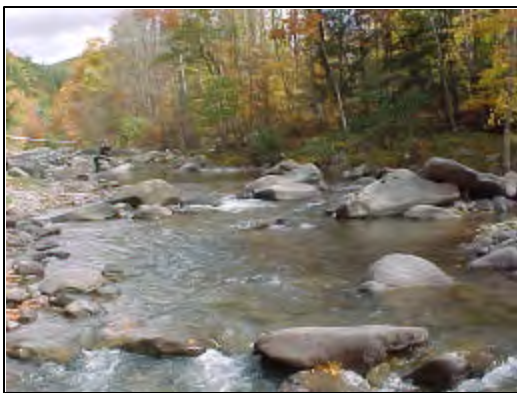
**Figure 11 Cross-section 181  
Stream Type F3b looking upstream**

reach (Inset C). The stream flows directly against the valley wall, increasing the *shear stress*, or force of flowing water, on the stream bank during high flow events. This hillslope, composed primarily of lodgement till, is being undermined by toe erosion, resulting in the mass wasting of the bank. Compounding this erosion problem, the face of the stream bank has been stripped of vegetation, leaving it vulnerable to erosion resulting from runoff from the steep hillslope above. The exposed lodgement till has a high silt and clay content, and contributes significant suspended sediment loads during high flow events. Clay inputs into a stream are a serious water quality concern because they increase *turbidity*, degrade fish habitat, and can act as carriers for other pollutants and pathogens.

The Bank Erodibility Hazard Index (*BEHI*) score of site #25 is ranked “High”, the third highest prioritization category in terms of its vulnerability to erosion (Fig. 12). This bank erosion site is considered one of the highest priorities for restoration due to its large eroding area, high shear stress, and its significant threat water quality.

Proceeding downstream, the channel slope increases to a steep 2%, changing stream type to F3b for the next 888 ft (Fig. 11). This reach consists of a series of cascades followed by plunge pools and rapids. The bed material is dominated by cobble but large boulders are abundant.

Bank erosion monitoring site #25 is located along 506 ft. of the right stream bank of this

From visual observations, it appears this bank erosion site is growing in severity and areal extent with each heavy rainfall. During the 2001 survey, it was estimated that the total erosion area of this site was 27,572 ft.<sup>2</sup>, qualifying it as the largest eroding area along the Stony Clove Creek.

Recommendations to restore this site would include stabilizing the toe of the right stream bank, and installing a bioengineered treatment of the hillslope. In-depth survey and design would be required to plan a stream restoration project at this site.

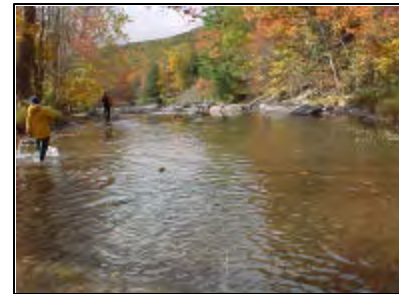
**Figure 10 Cross-section 180  
Stream Type F3**

As the stream widens and becomes yet more entrenched, stream type transitions to F3 for the next 180 ft. reach (Fig. 10). This reach is composed of a large glide, with an extremely flat channel slope of 0.4%.

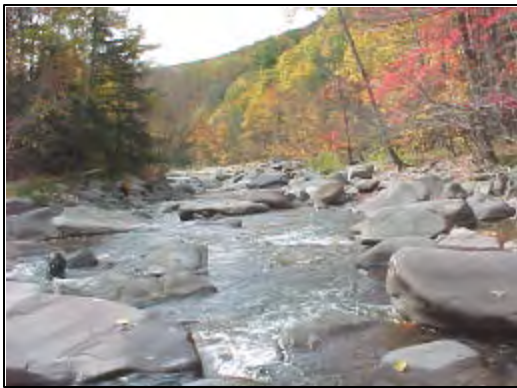
**Figure 13 Cross-section 182  
Stream Type B2**

As channel slope increases to 3.3% and the dominant bed material increases to boulders, the stream type transitions to B2 for the next 312 ft. reach (Fig. 13). This moderately entrenched reach is dominated by cascades. Stream reaches with boulder cascade morphologies are generally considered highly stable.
