Management Unit 19

Ulster County - Town of Shandaken
Chichester Bridge to Between Cross Section 186 & 187

Management Unit Description

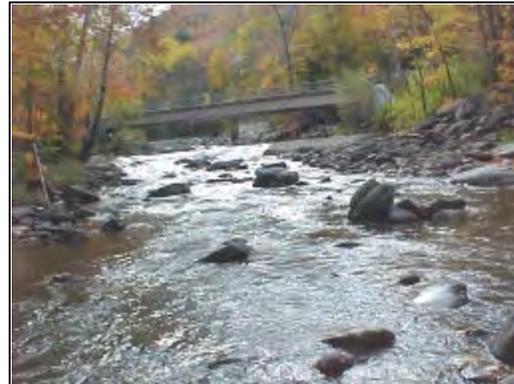
Figure 5 Stream Type B3 looking upstream

Management unit #19 begins as the Stony Clove emerges from under the Chichester Bridge, with a 191 ft. reach of B3 stream type (Fig.5). The stream channel is moderately *entrenched*, or confined within the stream banks during high flood events. The slope of the stream channel is 2.0%. The bed material is dominated by cobble, but large boulders and bedrock are abundant.

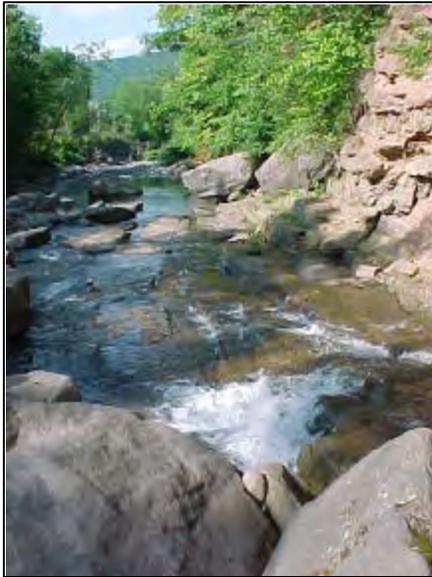
**Figure 7 Cross-section 178
Stream Type C2**

As the dominant bed material increases to boulders, stream type transitions to C2 for a short 168 ft. reach (Fig. 7). This reach remains steep with a slope of 1.8% and consists of a large cascade. For approximately the first third of this reach, the bed and right stream bank are bedrock.

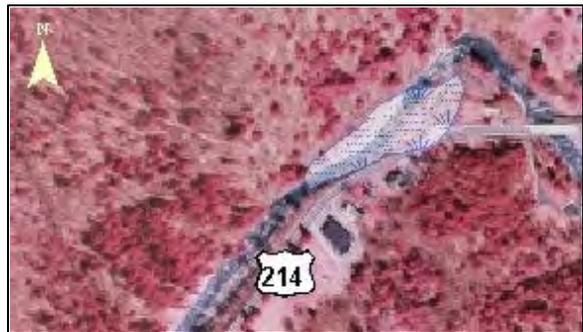
Figure 8 Federally Designated Wetland

There is a federally designated wetland along the stream in this management unit (Fig. 8). This wetland, which is 1.6 acres in size, is classified as palustrine scrub-shrub, broad-leaf deciduous, and temporarily flooded (PSS1A).

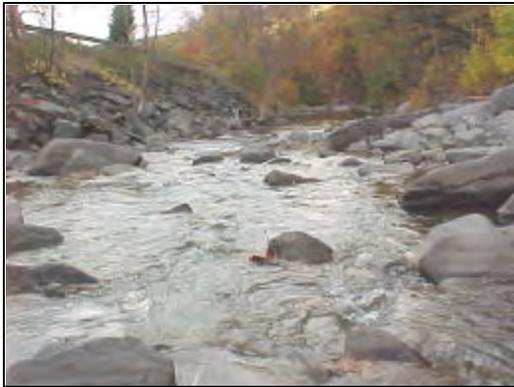
**Figure 9 Cross-section 179
Stream Type B3c**

The channel becomes moderately entrenched by the NYS Route 214 embankment on the left, and the dominant bed material decreases to cobble, as stream type changes to B3c for the next 306 ft. reach (Fig. 9). In the middle of this reach, the overflow channel rejoins with the Stony Clove mainstem. The *thalweg*, or deepest part of the stream, flows against the steep left stream bank. The NYS DOT has installed 326 ft. of rip-rap (Inset F) along the lower half of this bank.

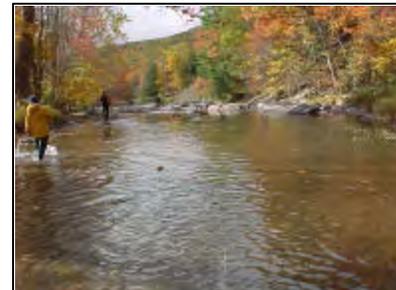
**Figure 10 Cross-section 180
Stream Type F3**

As the stream widens and becomes yet more entrenched, stream type transitions to F3 for the next 180 ft. reach (Fig. 10). This reach is composed of a large glide, with an extremely flat channel slope of 0.4%.

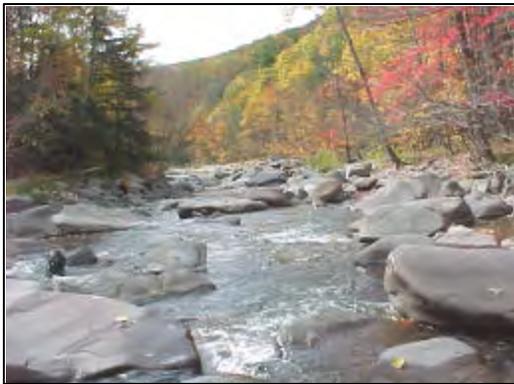
**Figure 13 Cross-section 182
Stream Type B2**

As channel slope increases to 3.3% and the dominant bed material increases to boulders, the stream type transitions to B2 for the next 312 ft. reach (Fig. 13). This moderately entrenched reach is dominated by cascades. Stream reaches with boulder cascade morphologies are generally considered highly stable.
