Local Flood Analysis

**Town of Hamden along the West Branch
of the Delaware River
Delaware County, New York
August 2017**

MILONE & MACBROOM®

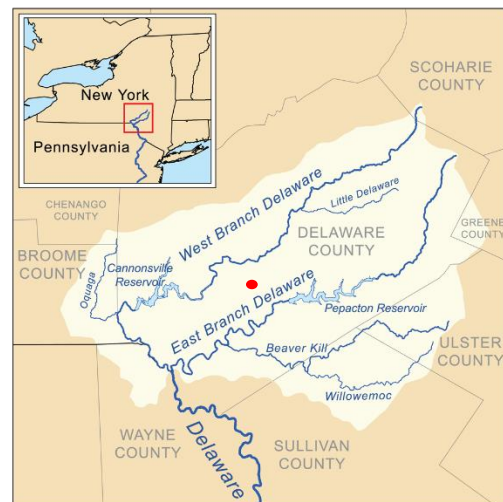
Figure 1-1: East Branch and West Branch Delaware River Watershed

The study area of the LFA coincides with the main population centers of the town, which are the hamlets of Hamden and Delancey. The study is focused on the West Branch of the Delaware River. The river's headwaters are located in Schoharie County. After entering Delaware County, the river flows in a southwesterly direction before entering the Cannonsville Reservoir, a drinking water supply source to the New York City public water system. The study area also includes Covert Hollow, Launt Hollow, and Chambers Hollow, all of which pass under State Highway 10, and Bagley Brook, which flows through the hamlet of Delancey. Figure 1-1 to the right depicts the West Branch and the East Branch relative to Delaware County and adjacent counties. The town of Hamden is indicated by the red dot.

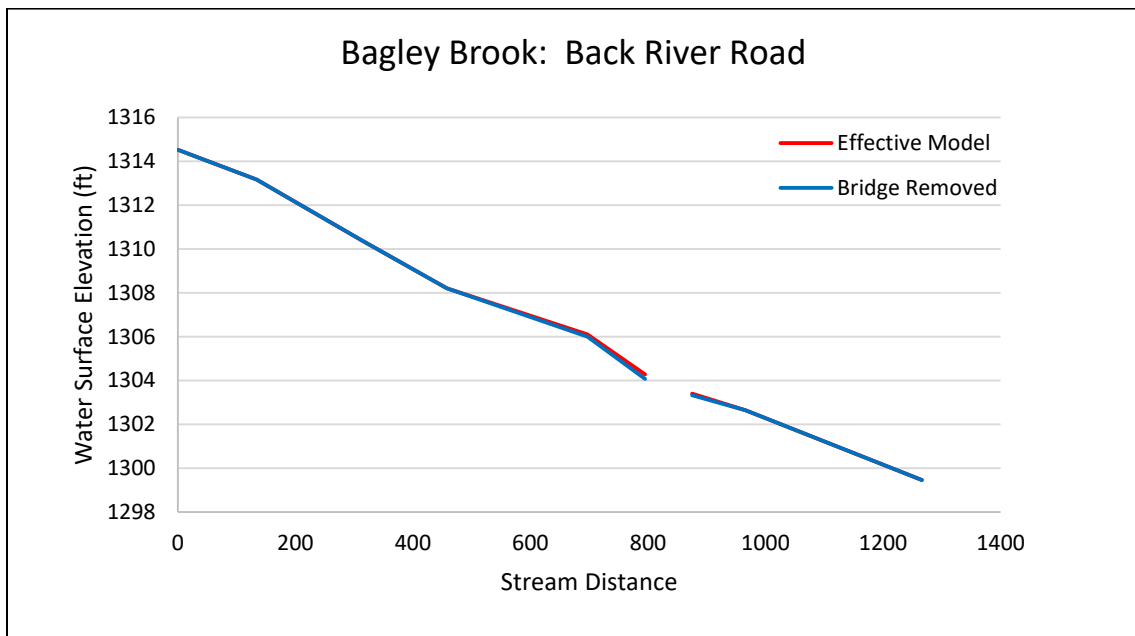
Figure 4-6: Expected Reduction in Water Surface Elevation at the 100-Year Discharge due to Structure Removal – Back River Bridge

On Bagley Brook, the removal of bridges resulted in modest reductions in water surface elevations. At the County Route 2 bridge, water surface elevations for the 100- and 500-year event decreased by approximately 1 foot when the structure was removed (Figure 4-5). The decrease in water surface elevation only persisted for a distance of 51 feet upstream. As the County Route 2 bridge easily passes the 500-year discharge, it more than adequately handles the largest flood events. The removal of the structure at Back River Road had very little effect on water surface elevations. Water surface elevations for the 100- and 500-year events decreased by about a quarter of a foot and were only seen at the cross section immediately upstream of the bridge (Figure 4-6). These minor reductions in water surface elevation did not result in flood mitigation at any structure.

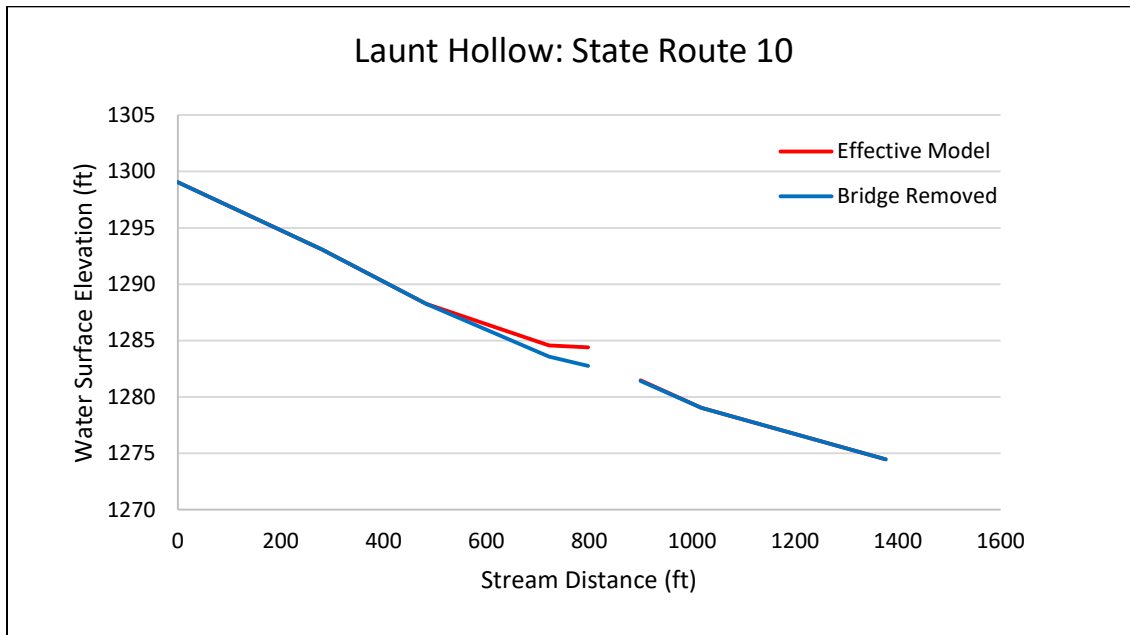
Figure 4-7: Expected Reduction in Water Surface Elevation at the 100-Year Discharge due to Structure Removal – State Highway 10 Bridge

The most significant effects of modeling bridge removals occurred on Launt Hollow at State Highway 10. The reductions in water surface elevations for the 25-, 50-, 100-, and 500-year events were 0.93 feet, 1.27 feet, 1.63 feet, and 2.64 feet, respectively (Figure 4-7). However, this did not result in any appreciable mitigation benefits. The only benefit was for a single home upstream of the bridge. This structure, which was normally inundated by the 500-year event, avoided flooding with removal of the bridge.

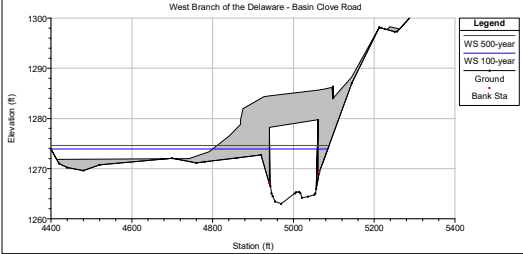
West Branch Bridges – Basin Clove Road:

West Branch of the Delaware - Basin Clove Road

- WS 500-year
- WS 100-year
- Ground
- Bank Sta

Basin Clove Road (covered bridge) over West Branch – The bridge was originally built in 1859 and was rebuilt and raised up in 2000. It was noted that bankfull flow events overtop the floodplain upstream of the bridge and flow across the floodplain area river left of the bridge. This results in inundation of Basin Clove Road on the east side of the river.

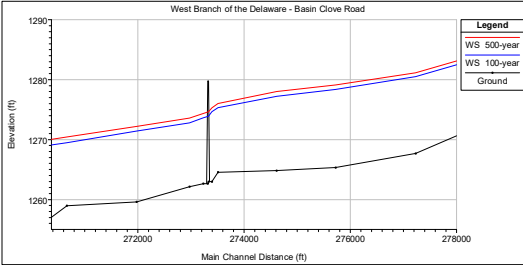
West Branch of the Delaware - Basin Clove Road

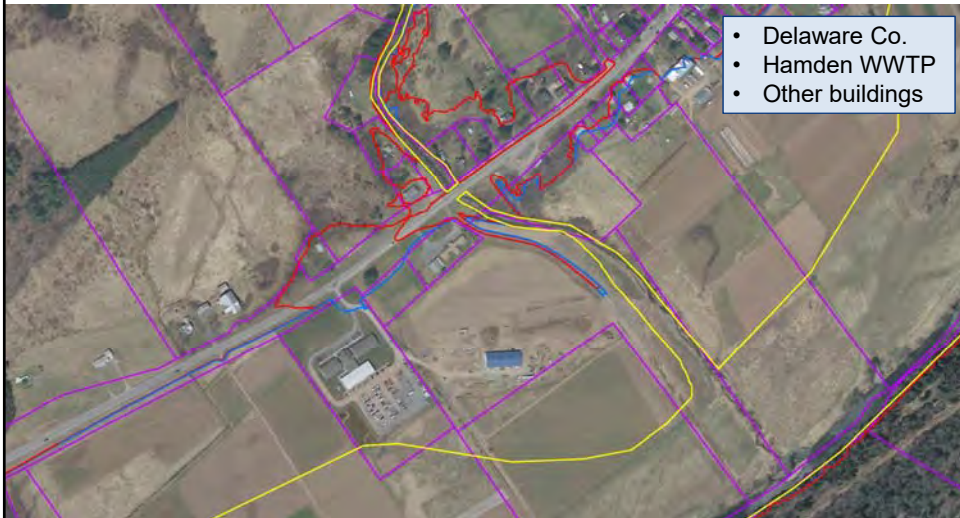
Launt Hollow at West Branch:

- Delaware Co.
- Hamden WWTP
- Other buildings

County Route 10 culvert over Launt Hollow – FEMA model indicates that the 100-year flood remains in the channel while the 500-year flood overtops the right bank and causes flooding of one structure and surrounds another. Town occasionally (approximately every three years) removes sediment at the downstream side of this 4-sided box culvert, extending approximately 350 feet downstream. Channel dimensions are provided by DCSWCD. Permit is obtained. It has been about three years since removal took place so it is due to be done soon. In 2007 or 2008 there was a project to reconstruct the channel downstream of the culvert, with installation of a floodplain bench and riparian plantings.

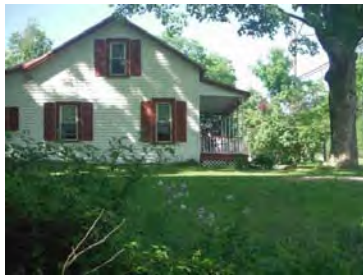
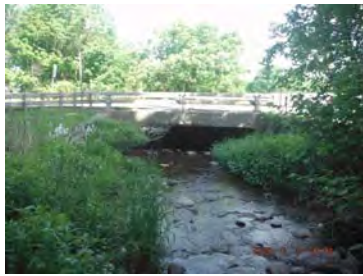
Route 10 bridge over Covert Hollow:

- No detailed FEMA maps or profiles

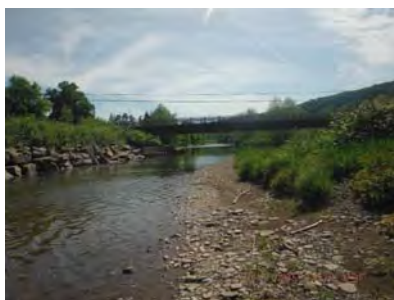
Bridge Adequacy

- Flooding of Bridge Approaches on West Branch of Delaware (all during 10-year flood event)
 - County Route 2 – Flooding occurs on western bridge approach
 - Basin Clove Road – Flooding occurs on eastern bridge approach
 - County Route 26 – Flooding occurs on northern bridge approach
