4. Water Quality and Ecological Health

a. Chestnut Creek Fisheries Management

Chestnut Creek Stream Management Plan

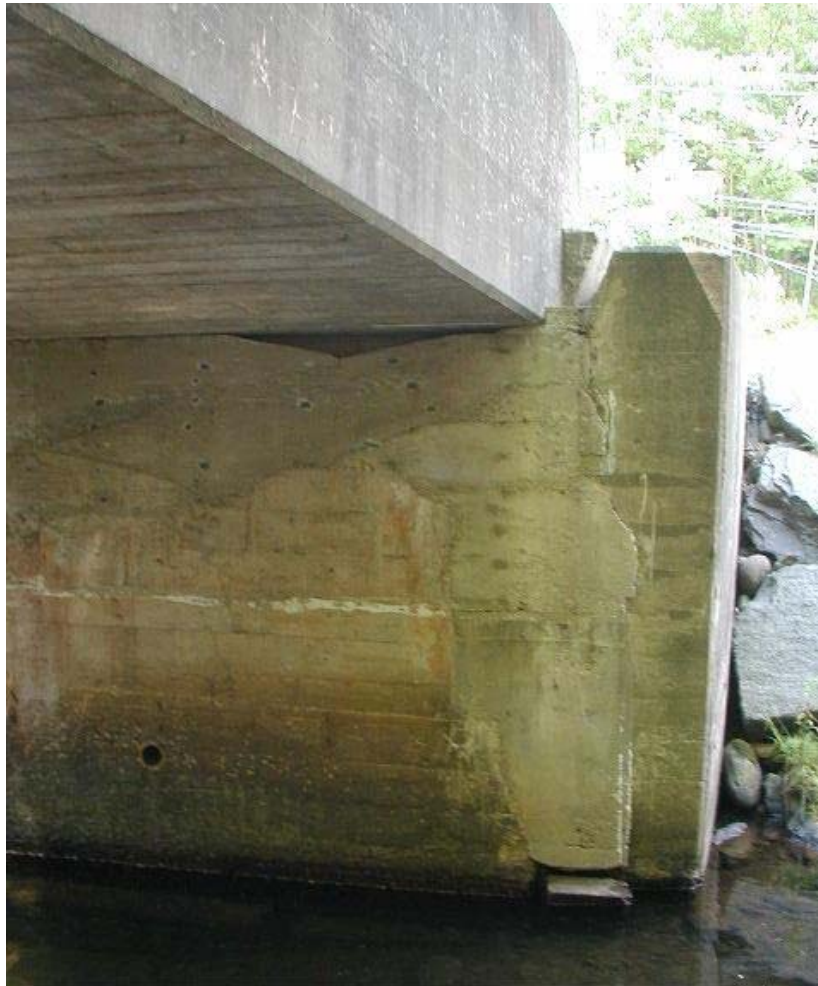
Mohr Bridge. Photo taken by Lori Kerrigan, SCSWCD.

Mohr's Bridge - This bridge is located across from Maschio's Restaurant concerns the Highway Department because the abutment closest to the road is being undercut. If Mohr's Bridge collapses it may cause damage to Route 55 and will be addressed as deemed necessary.
