4.0 Introduction to Management Unit Descriptions and Recommendations

This section contains the observations of the condition of the upper Rondout Creek made during the walkover assessment that was conducted in 2008-2009. Detailed descriptions and specific recommendations are presented for the stream length existing from the top of the watershed near Peekamoose Lake, downstream to the Rondout Reservoir. The exception to this is those areas on New York State lands, which are in "forever wild" status and thus are left unmanaged and self-willed. The Rondout mainstem has been organized into 17 Management Units (MUs) defined using physical stream characteristics, historical channel alignments, location of bridges and road infrastructure, and valley characteristics. The major tributaries, including the Rondout headwaters above Peekamoose Lake, will be inventoried in future assessments; the exception is the first portion of Sundown Creek (aka East Branch of the Rondout), which has been included due to the predominant role it plays in conditions on the mainstem at the confluence. This section of Sundown Creek has been designated Management Unit 18.

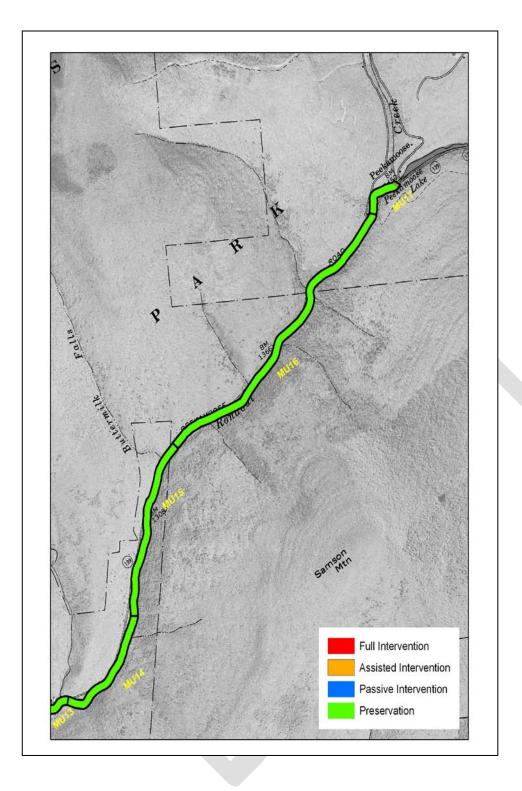
Figure 1

This intervention level map begins at a private bridge crossing the outfall of the Peekamoose Lake dam where it enters the Rondout Creek, and continues downstream approximately 3.25 miles along Peekamoose Road until it passes under a bridge over the Rondout Creek at the trailer field in NYS DEC Peekamoose Valley Camping Area. This map encompasses Rondout Creek management units 17 through 14.

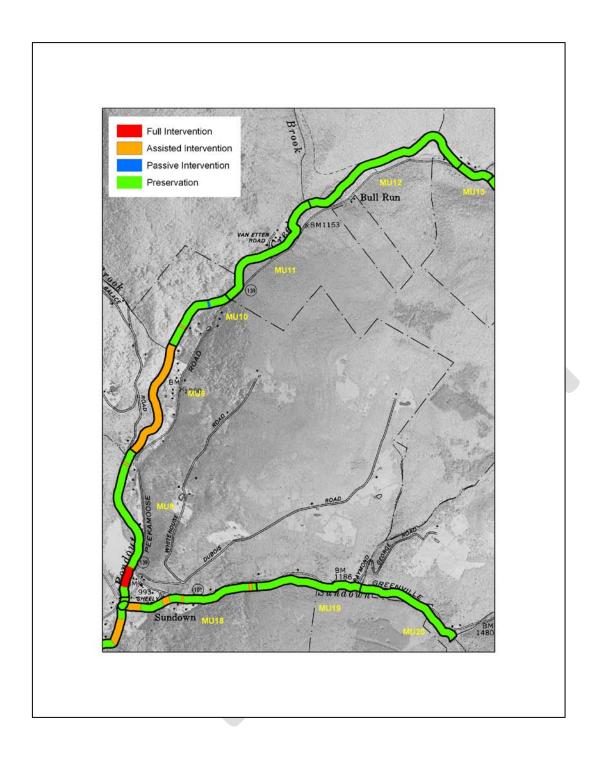
Figure 2

From the trailer field in NYS DEC Peekamoose Valley Camping Area downstream 3.1 miles under the Sundown Bridge on Peekamoose/Sundown Road including lower sections of Sundown Creek for 1.8 miles up Greenville Road. [Rondout Creek Management Units 8-13 and Sundown Creek Management Units 18-20].

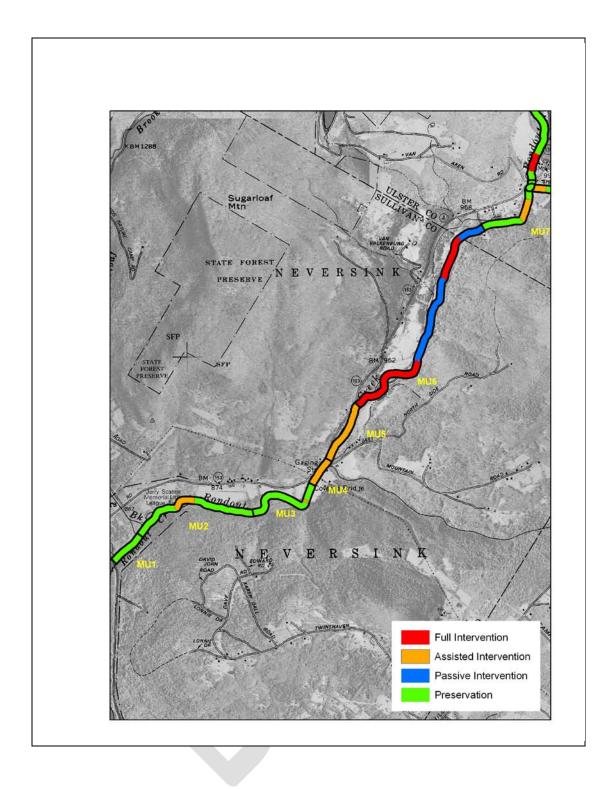
Figure 3
This intervention level map begins at the Peekamoose/Sundown Road Bridge where the Sundown Creek enters in the Rondout Creek, and continues downstream approximately 3.5 miles along Sundown Road until it empties into the Rondout Reservoir at the Route 55-A Bridge. This map encompasses Rondout Creek management units 7 through 1.
