Section 3.3 Watershed Assessment and Inventory

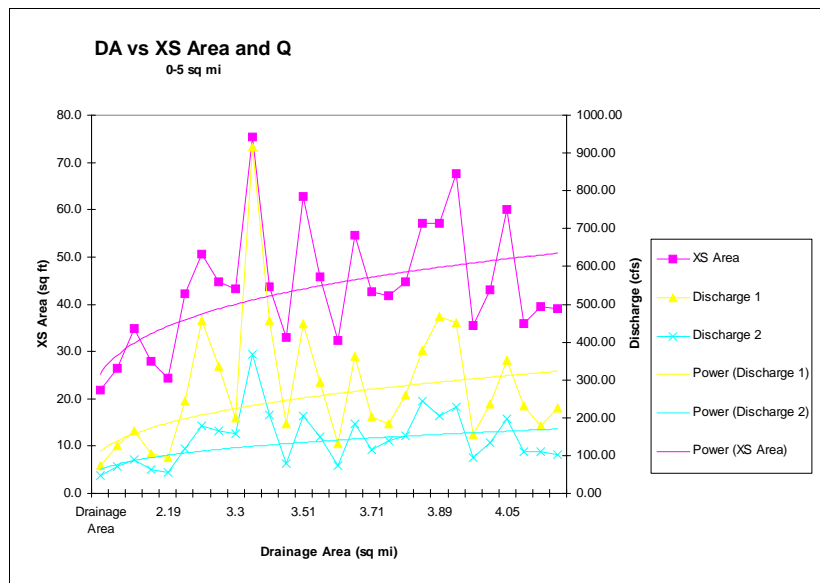
Figure 1 Validation of bankfull stage identification, using comparison of cross-sectional areas

The second pass involved elevation survey of the longitudinal profile of current water surface and field identified bankfull stage, and the third involved elevation survey of the (92) reference cross-sections described above. Following this survey, a stream-specific hydraulic geometry curve was developed for these cross-sections to support determination of bankfull stage at the remaining cross-section locations established during the stream feature inventory (Fig. 1). (Discharge was added later, back-calculated at each cross section using slope and pebble count data, and two different equations). Bankfull stage was rechecked in the field at high and low outliers.

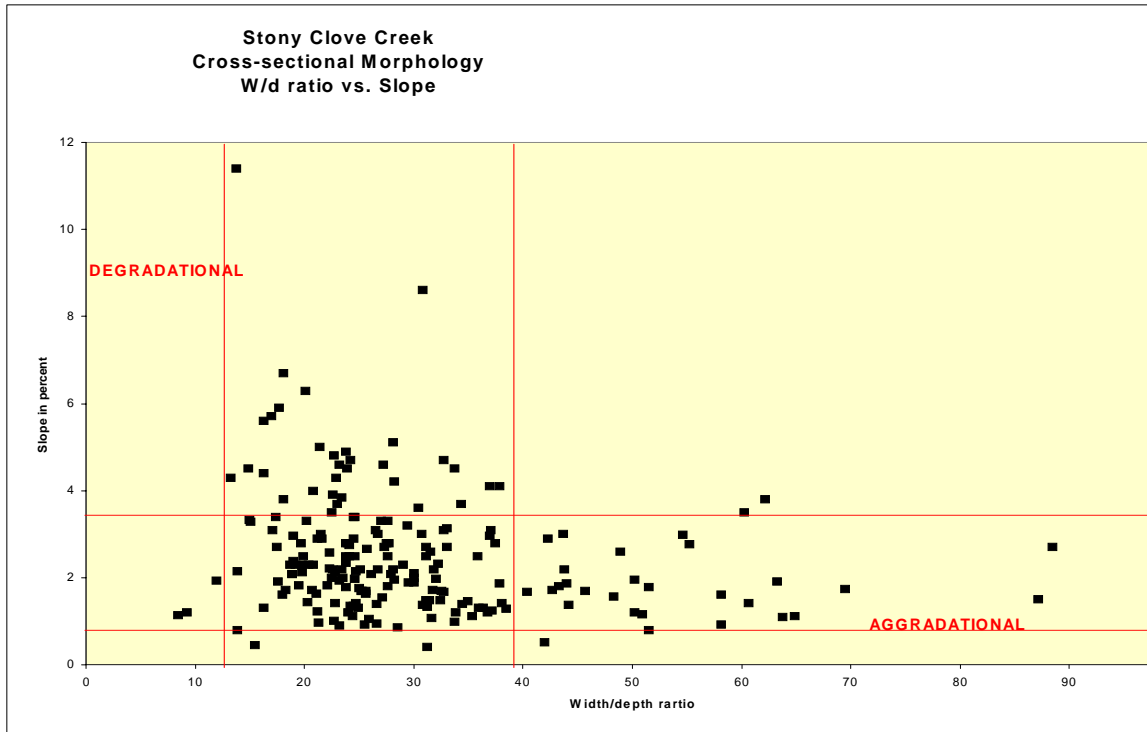
Additional data analysis was used for specific interpretations. Figure 6 depicts width/depth ratios and slope for the 199 cross-sections. In the absence of some other mitigating characteristic, reaches falling in the upper left are likely to have excess transport capacity, and those in the lower right, insufficient transport capacity.

Figure 6 Width to depth ratios vs. slopes for 199 cross-sections, suggesting sediment transport effectiveness
