Section 3.3 Watershed Assessment and Inventory

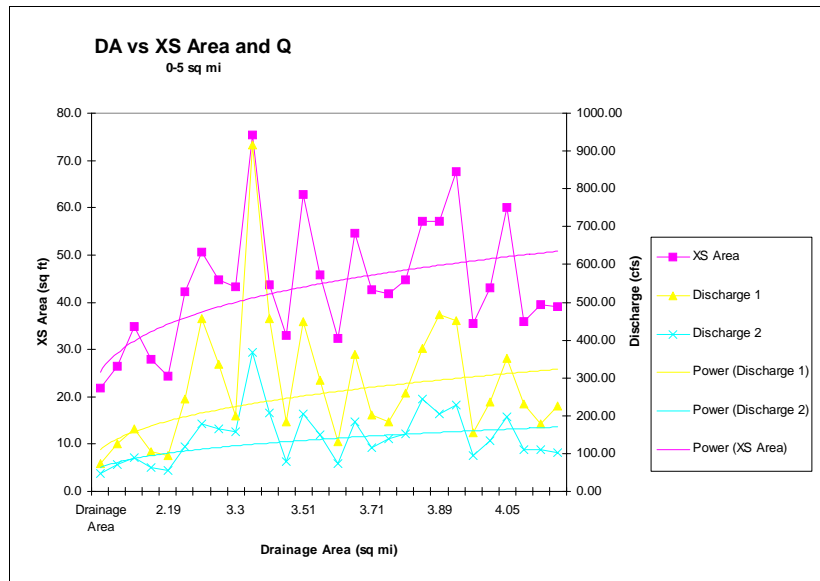
Figure 1 Validation of bankfull stage identification, using comparison of cross-sectional areas

The second pass involved elevation survey of the longitudinal profile of current water surface and field identified bankfull stage, and the third involved elevation survey of the (92) reference cross-sections described above. Following this survey, a stream-specific hydraulic geometry curve was developed for these cross-sections to support determination of bankfull stage at the remaining cross-section locations established during the stream feature inventory (Fig. 1). (Discharge was added later, back-calculated at each cross section using slope and pebble count data, and two different equations). Bankfull stage was rechecked in the field at high and low outliers.

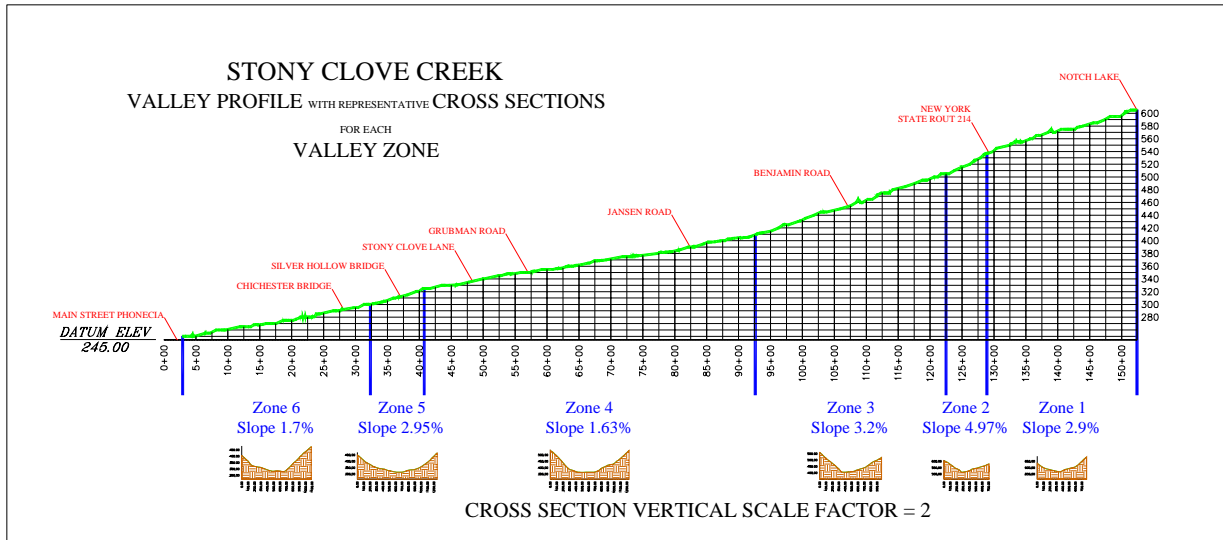
1) Valley Slope - A profile of the valley slope was created using United States Geologic Survey contour data (Fig. 2). This profile was divided into segments based on common slope characteristics.

Figure 2 Stony Clove Creek Valley Profile

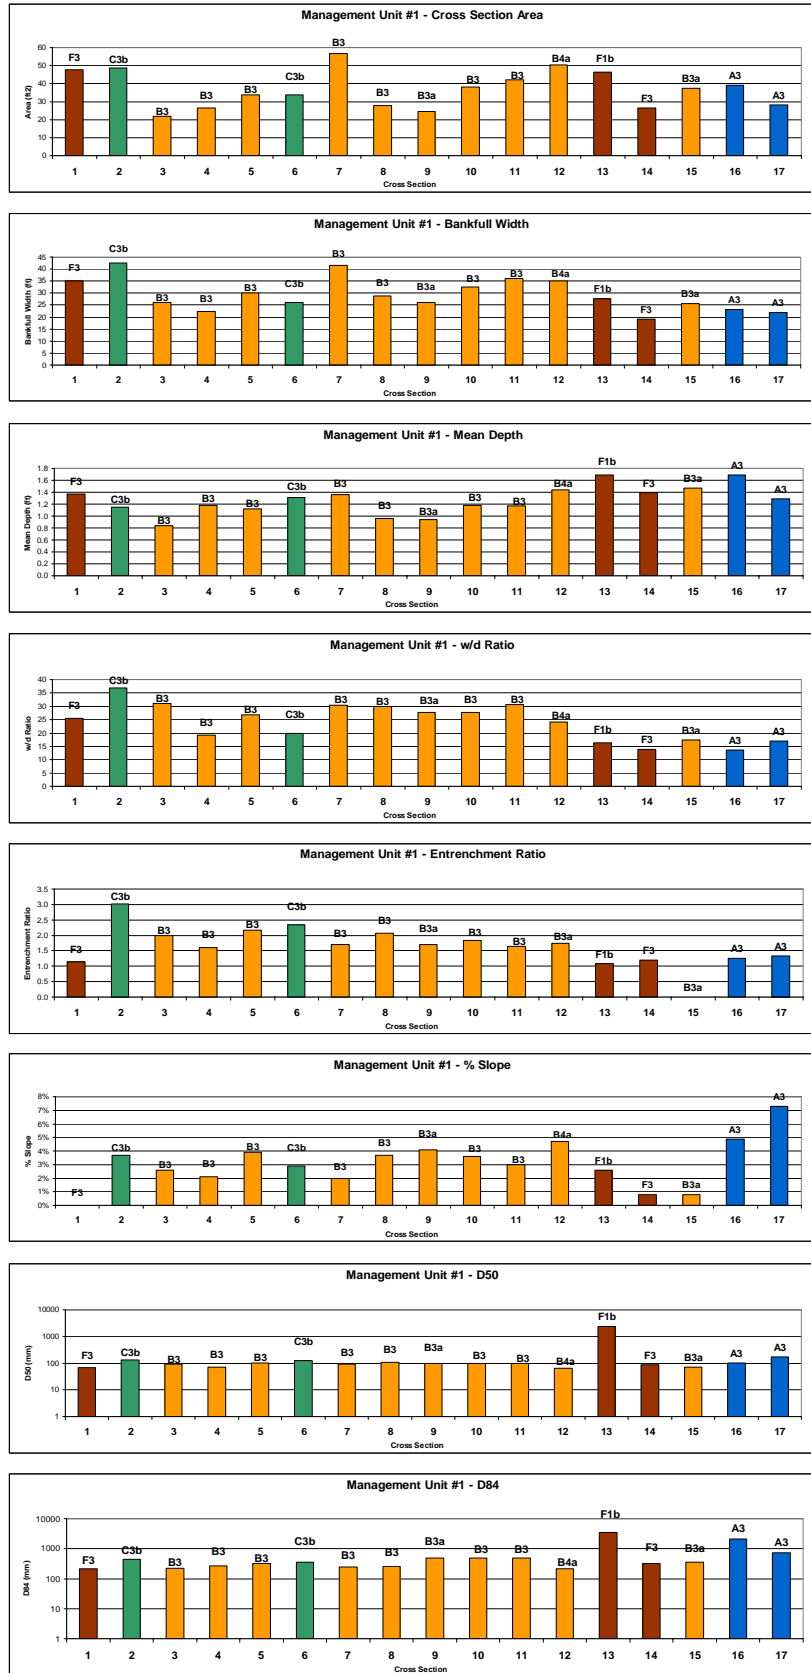
Figure 3 Channel morphology characteristics for Management Unit 1

The resulting 21 management units are reflected in the 21 units described in Section 4. The data were then compiled by management unit to facilitate interpretation of conditions, trends and to make recommendations. Figures 3-5 illustrate the format used for data analysis. These data are available for review at Greene County Soil and Water Conservation District.

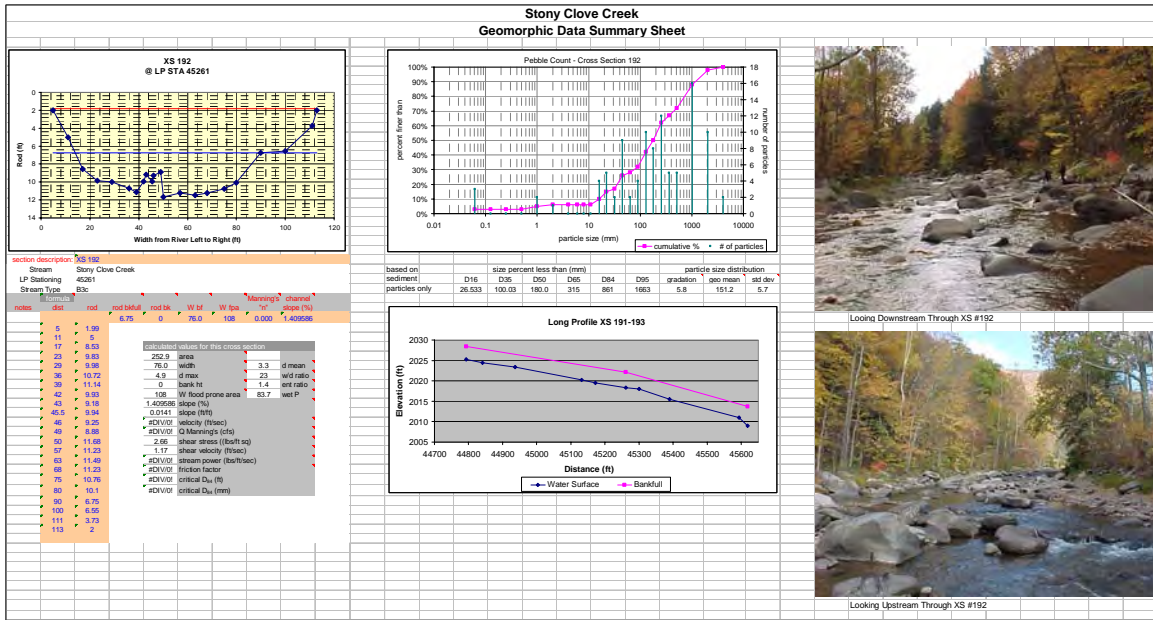
Figure 4 Reach morphology summary page

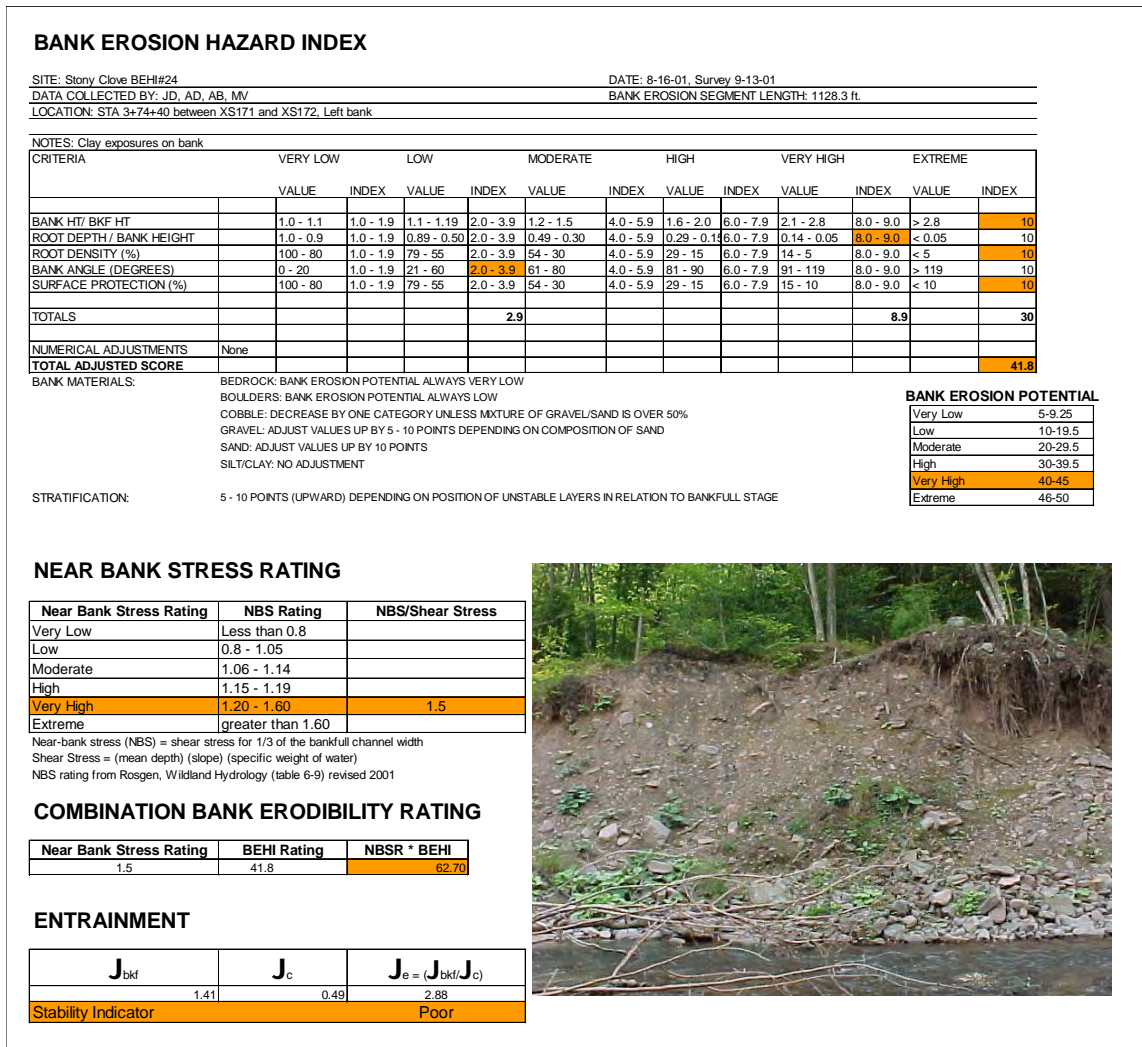
Figure 5 Bank erosion site summary sheet
