Riparian Corridor Management Plan Schoharie Creek

Kelly Property – Tannersville, NY

January 7, 2011

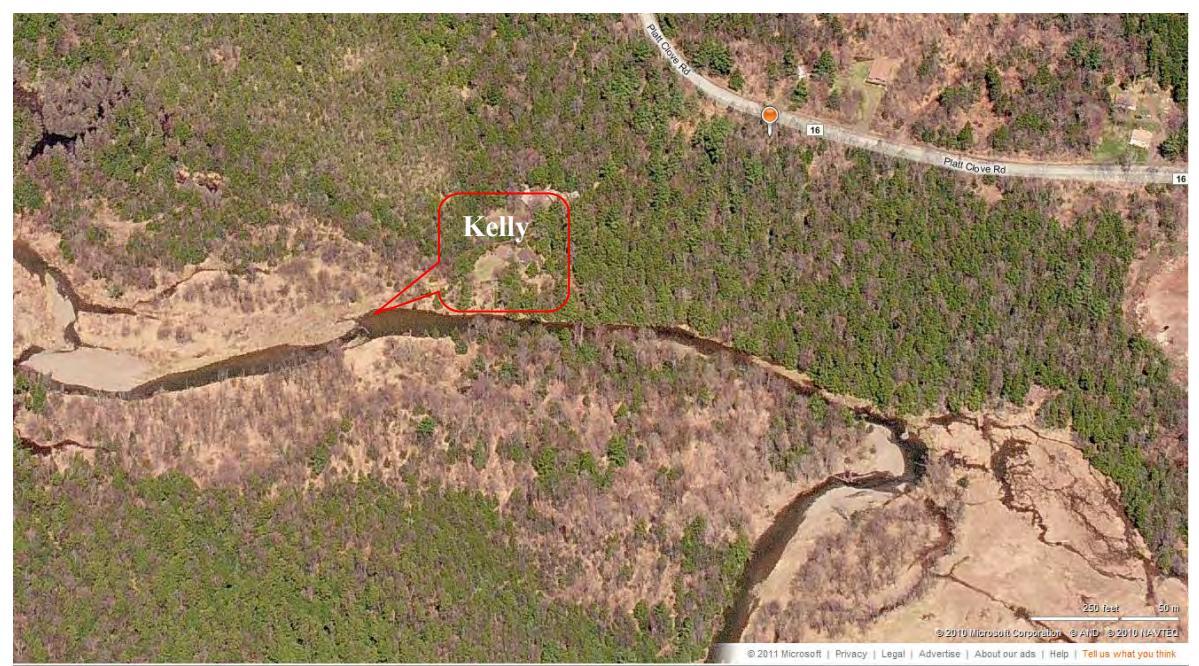
Aerial view of Kelly property on Platte Clove Road

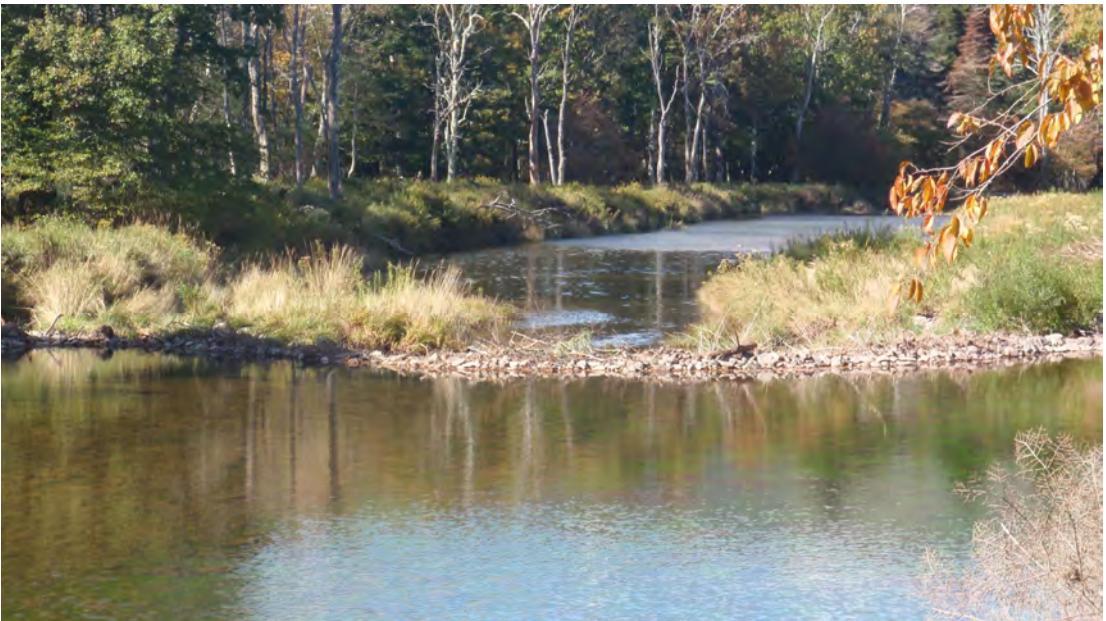
Beaver dam, September 2010

Due to its rural nature and headwater location in the watershed, this section of the Schoharie has a lot of beaver activity. While beaver impoundments can sometimes be a nuisance, beavers have historically played a beneficial and ecologically important role in the stream system. Beaver activity adds organic debris (trees, leaves, etc. which provide the base of the food chain), reduces water velocities and flood-related hazards downstream, and creates wetland areas that filter sediment and release water to the stream and groundwater slowly throughout the year.

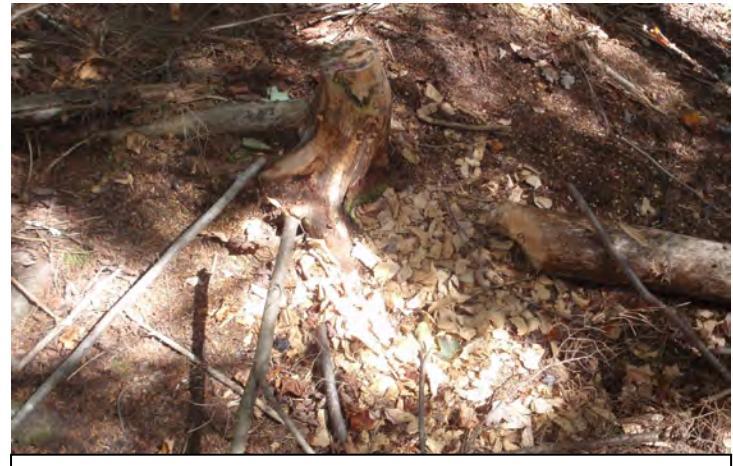
Beavers can heavily damage riparian plantings, usually most severely in the sapling stage. Most damage occurs in the fall as the beavers are preparing their winter cache of browse. The tree species preferred by beavers include alder, aspen, birch, cottonwood, maple, poplar and willow. Beaver activity is a natural occurrence in the Catskill region, and it is a goal of the CSBI program to enhance riparian zones using methods that are sustainable to local wildlife populations. Under the appropriate conditions, efforts can be made to help prevent planted trees from being damaged by beavers, including the installation of a collar of galvanized steel screening.

Evidence of recent beaver activity in fall 2010

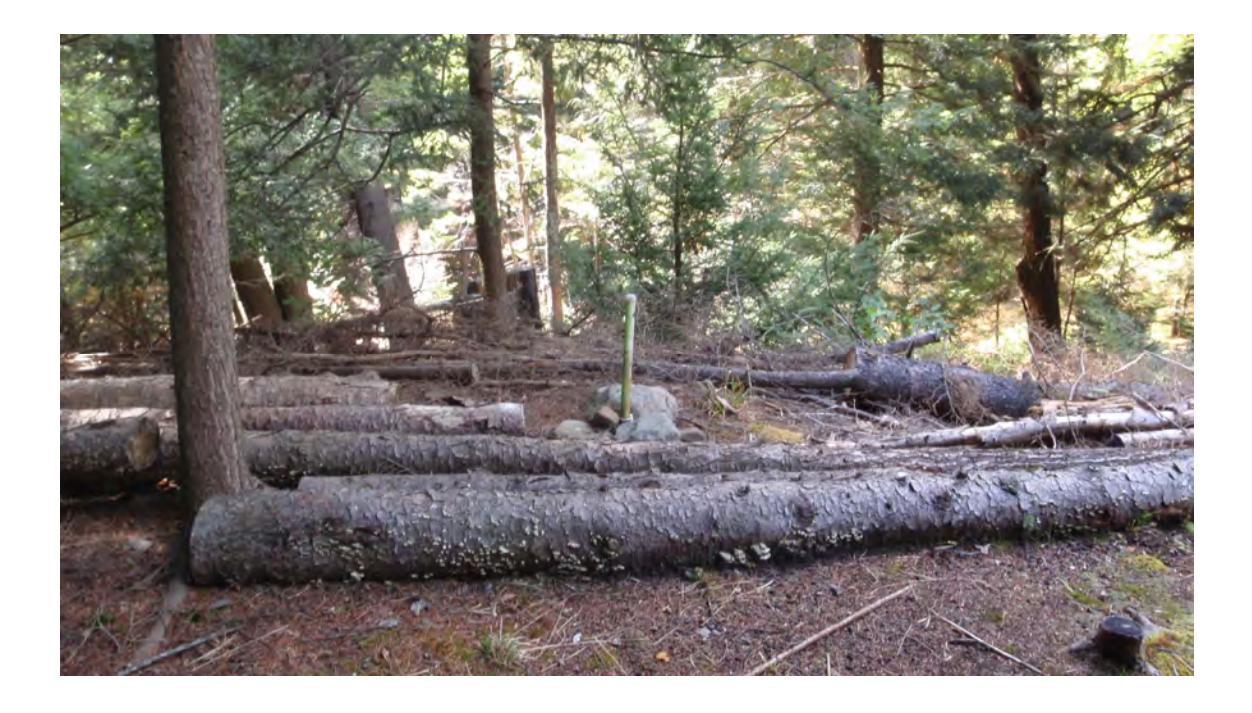
The primary residence on the Kelly parcel is located at the top of a steep hill slope facing the stream. A significant amount of yard debris (branch cuttings, wood piles, etc.) had been placed at the top of this slope. Although the slope is well vegetated with mature trees and appears relatively stable at this point in time, adding the weight of yard debris can add excess stress and lead to slope failures.

4) Stop adding heavy debris to high slopes. Excess weight from accumulation of yard waste (see figure below) may stress slopes and increase the likelihood of slope failure. Dispose of yard debris away from the stream banks and hill slope.
