Schoharie Creek Embankment Repair At Schoharie Street

Project Implementation Report

Village of Hunter, Greene County, New York

Update: December 2009

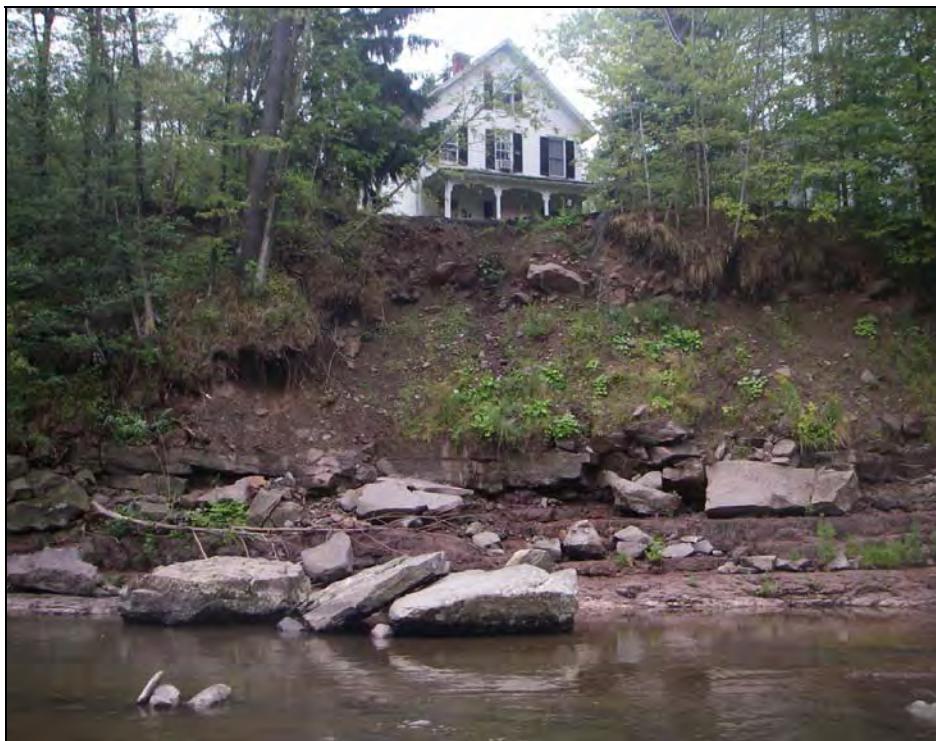
Figure 1 - Bank Failure at Schoharie Street Project Site

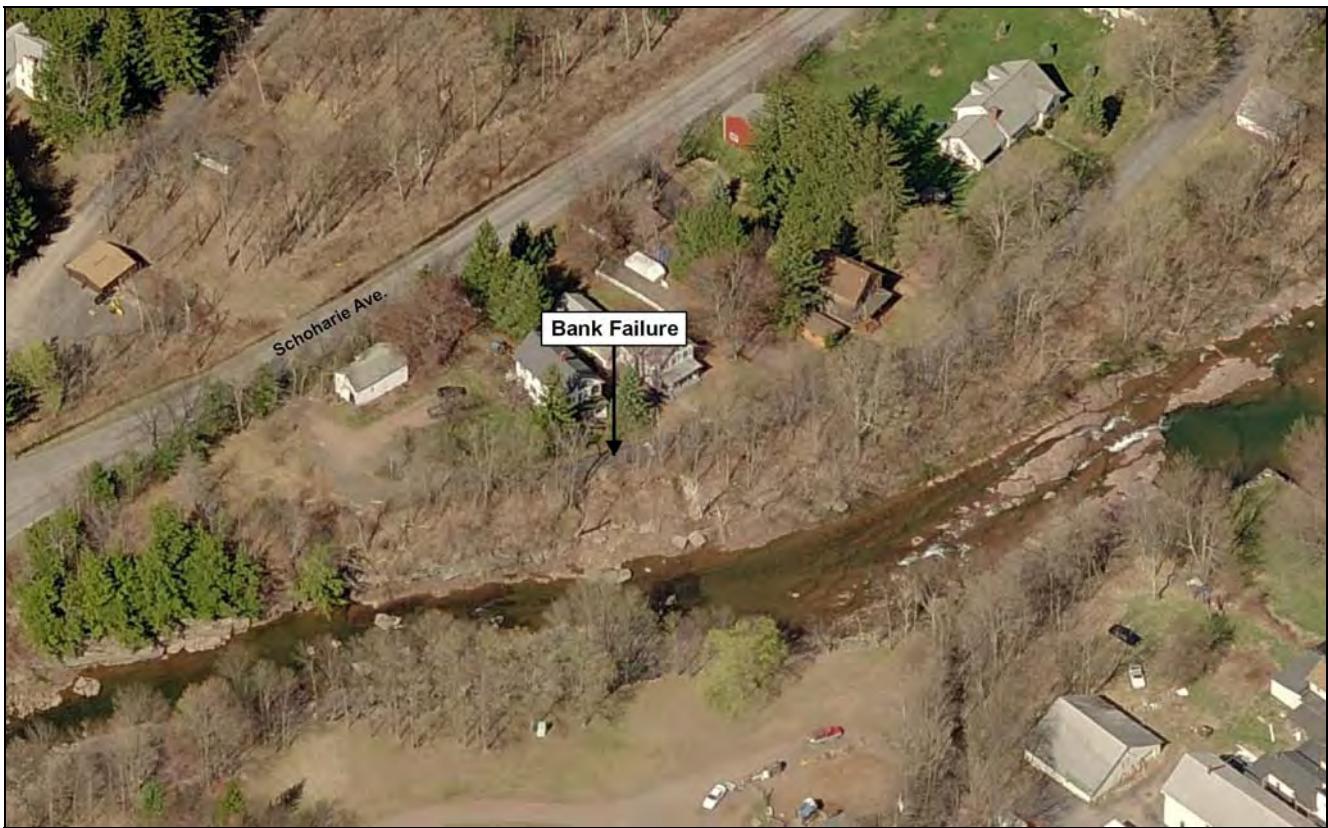
Figure 2 - 2006 aerial photograph of bank failure at Schoharie Street Stabilization Project

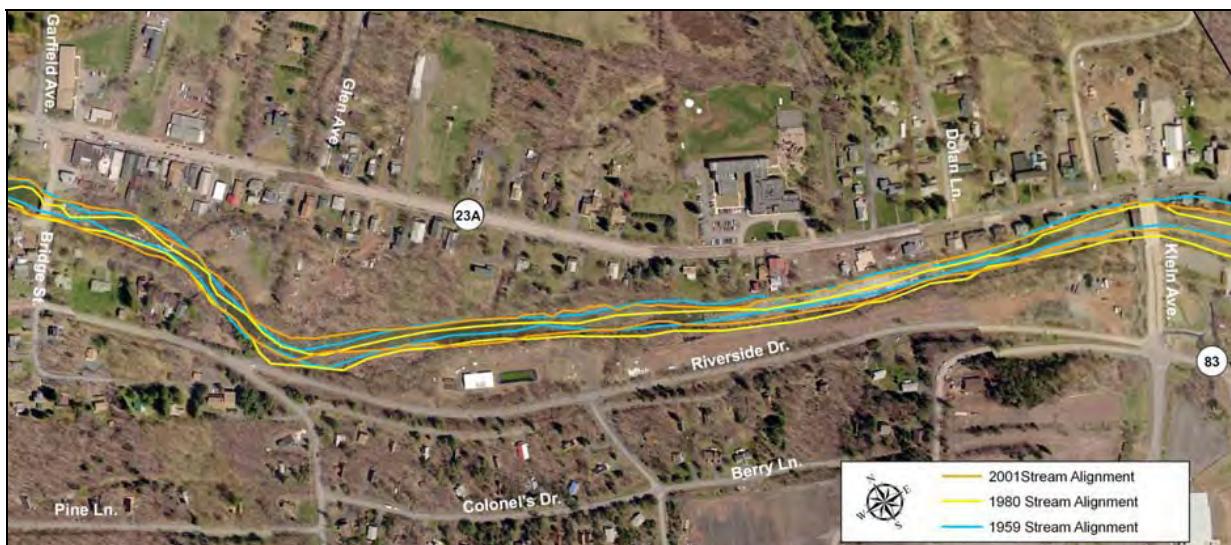
Historic aerials from 1959, 1980 and 2001 were assessed to observe physical conditions of the reach including response and patterns in planform adjustment and trends in stream morphology. As seen from the historical stream alignments (below), the planform of the channel has remained fairly stable since 1959.

Figure 3 - Historic channel alignments for Schoharie Creek in the Village of Hunter

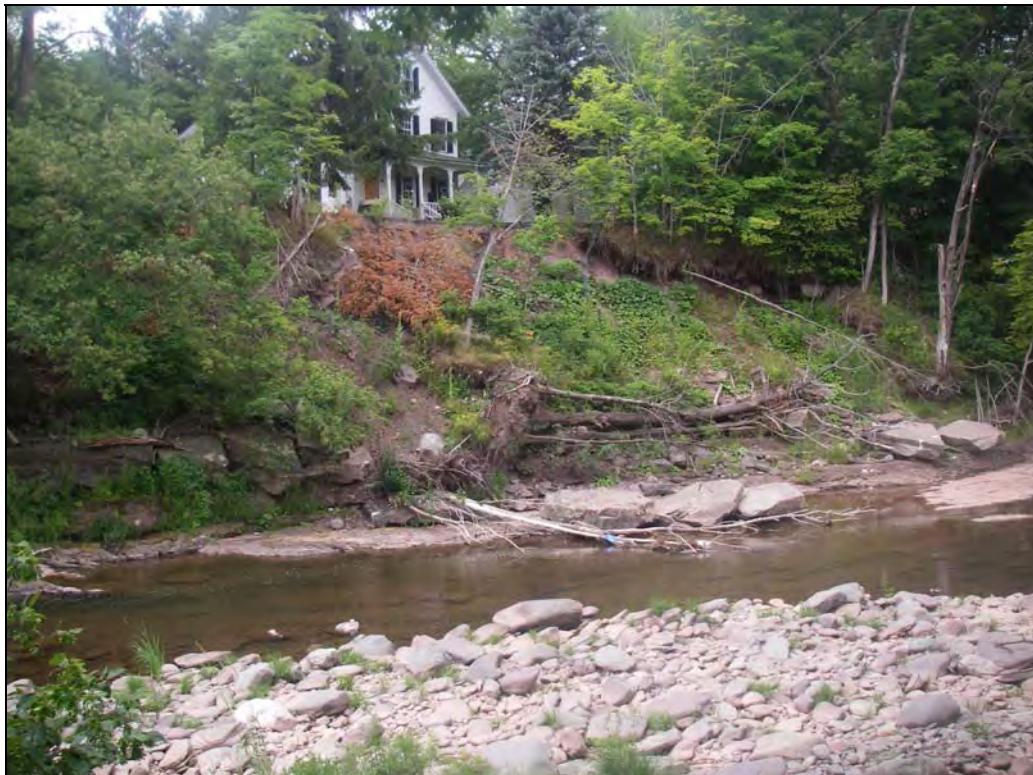
While the channel bed and lower banks were comprised of various types of bedrock, the upper slope contained much finer grained materials that were much more prone to failure.

Figure 4 - Fractured bed rock at the toe of the bank failure

Stream erosion at this site had fractured the lower shale bedrock bank and triggered a 9,432ft² shallow failure on the upper hillslope. At the top of the slope, the Village had been forced to close the end of Schoharie Street due to safety concerns. Erosion along the right streambank had scoured an area of 2,179ft².

Geotechnical evaluation of the slope failure resulted in recommendations to stabilize the failure through the establishment of stable bank geometry and construction of a stacked rock wall. The bank geometry necessary to achieve stability was determined to be 1:1.

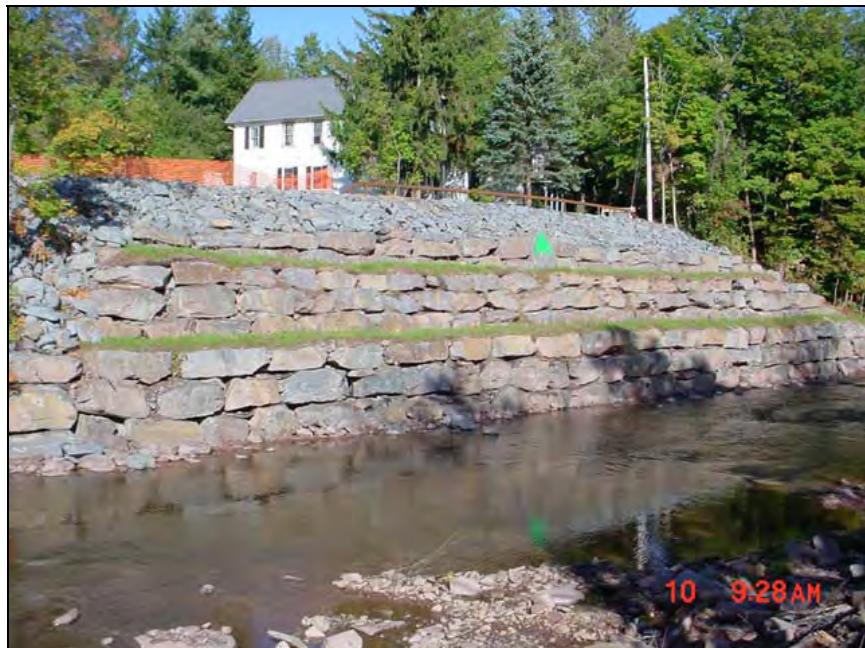
Figure 6 - Completed Embankment Repair

The wall was constructed on a footer that was keyed 1 foot into the bedrock toe of the slope to prevent movement of the base course of the wall. A minimum of two rebar pins were installed through each base rock to further ensure that the base course of rock would not move under stress. Embankment repair elements of the project were funded by a combination of FEMA and NYCDEP funding. A summary of the project expenditures classified by funding source is presented in Table 1.

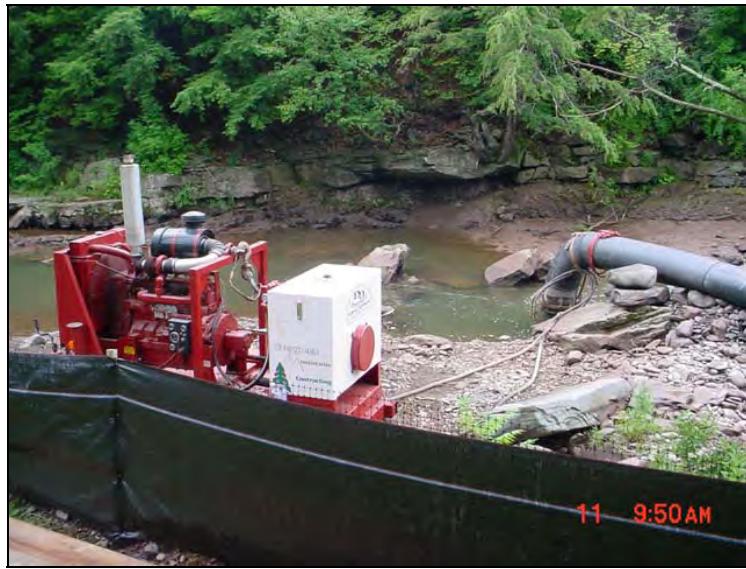
Stream channel construction was required to be completed in a dry condition in order to meet the requirements of various regulatory agencies. During all construction in the stream channel, the contractor was required to divert the entire stream flow around the work area. Dewatering was maintained 24 hours per day, 7 days per week during the construction period and was accomplished by a pump and pipeline scenario. The approximate capacity of the dewatering system was 50 ft³/sec. Stream flow exceeded pumping capacity following a rain event on July 23, 2008, stopping work until flows fell back into the capacity range of the dewatering equipment on August 7, 2008.

Figure 7 - Dewatering equipment Installed on Site

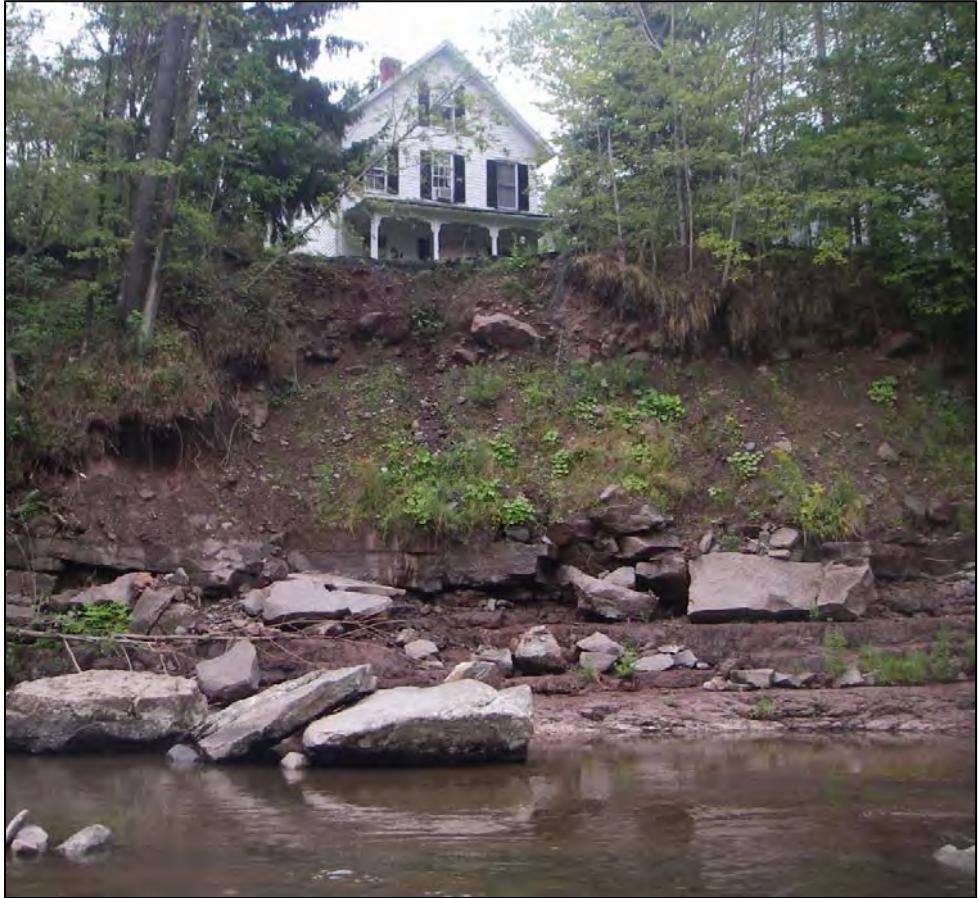
Existing Site Conditions

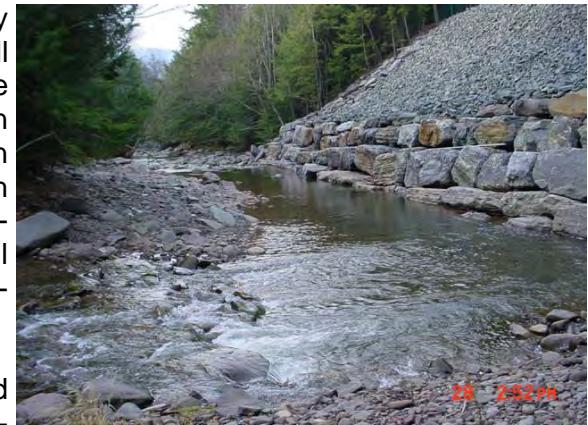
Rockery walls were designed in order to achieve the bank geometry necessary to assure stability of the embankment. The walls will be anchored into bedrock at the toe of the embankment. Three terraces will be constructed with each of the three walls having an appearance similar to that of the rock wall pictured to the right. An important difference from the wall pictured at the right is that each terrace will be fitted with soil beds which will be planted with native shrub species appropriate for the setting. The plantings will improve the ecological value of the project while significantly enhancing the aesthetic of the finished project.

Rockery Wall on Gooseberry Creek.

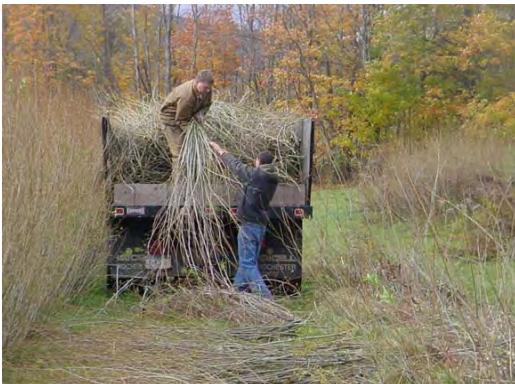
Willows being harvested at the PMC; to be used for willow fascines.
